Inspection System for Old Public Buildings and Apartments in Colombo Municipal Areas

Building Material Research & Testing Division, National Building Research Organisation, Sri Lanka.

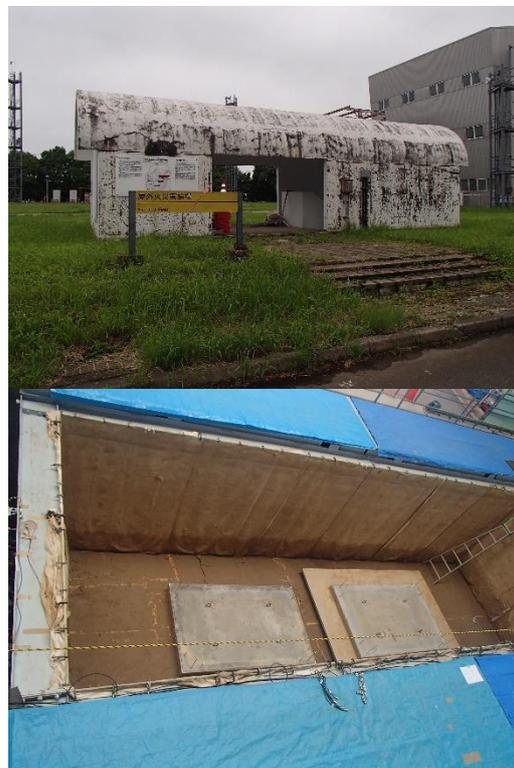
Figure 1 shows fire testing in Japan. In Sri Lanka there is no laboratory having a similar test facility.

Figure 1: Building tested for fire behavior and laboratory fire testing arrangement

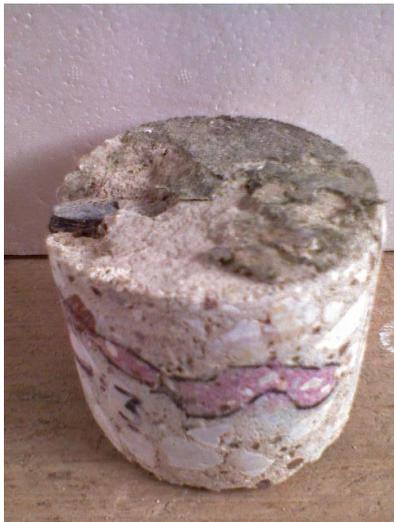
Figure 2 shows a core sample taken from the wall of the 100 years old government building in Kollupitiya which was tested for depth of carbonation. Carbonation was found to have occurred both sides and only small portion on middle part remained uncarbonated.

Figure 2: Sample tested for depth of carbonation
