We are happy to invite you to read the 2nd issue of NBRO Newsletter in the year 2019. This issue addresses construction of buildings and it also contains few articles from other disciplines as well.

Technical Guidelines on Building Demolition Work in Sri Lanka

Dome Houses and their Impact on Resettlement in Sri Lanka

03 Practical Barriers in Implementing Resilient Construction Methods in Resettlement Housing Schemes

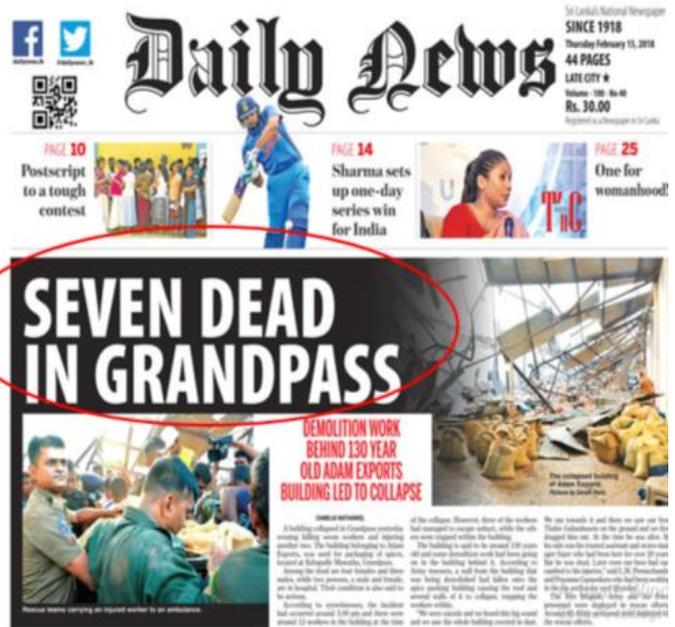
A recent collapse (15.02.2018) of a building due to improper building demolition work at the adjoining site

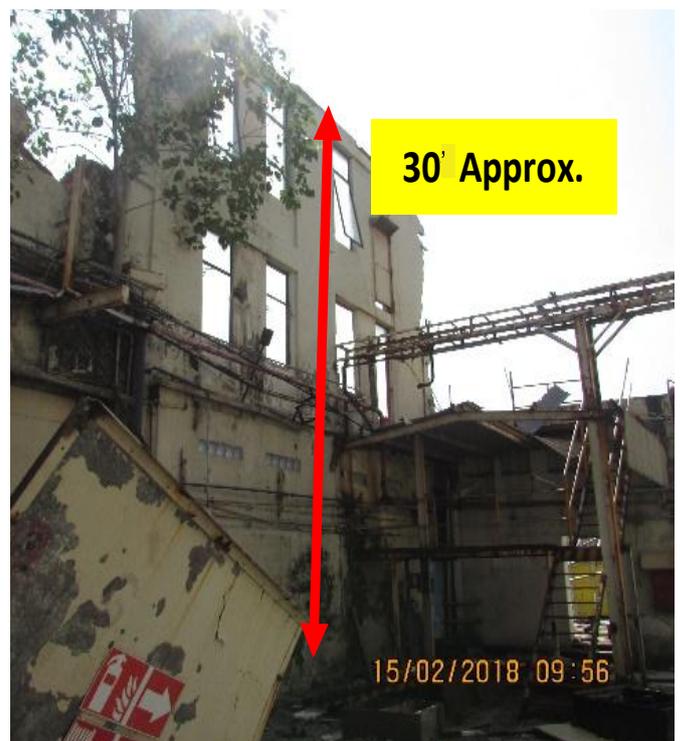
partial collapse of a warehouse in Grandpass, Colombo 14 in February 2018 as a result of demolition work of an adjoining building that had taken place without following proper safety standards.

- (a) Improper Demolishing site; unsafe free standing walls without lateral supports
- (b) Collapsed warehouse building

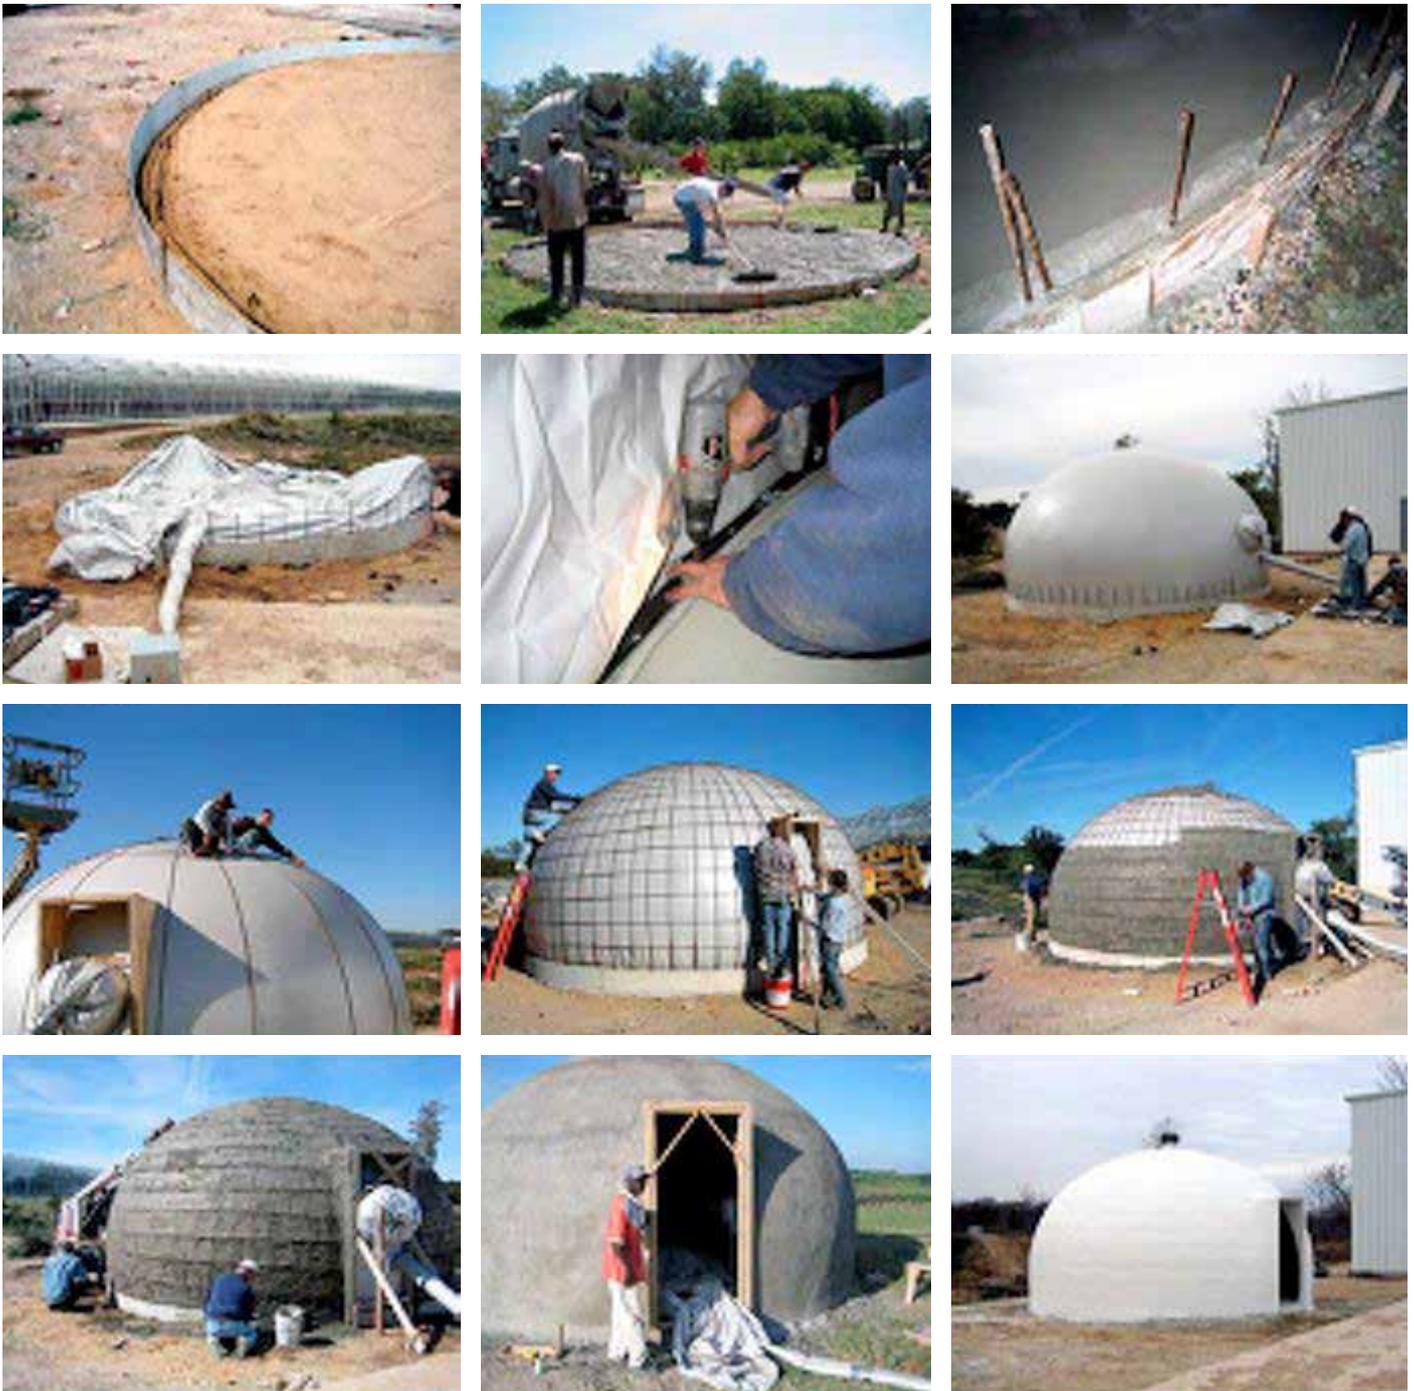
Figure 01: Dome house construction process
(Source – Hammer, C. (2006). Optimization of Dome Housing in Sri Lanka)

When considering about the technical aspects of the dome house construction, the design is more suitable for the house constructions in flat terrains. Comparatively to the contemporary construction methods which are currently practicing in Sri Lanka, it saves construction

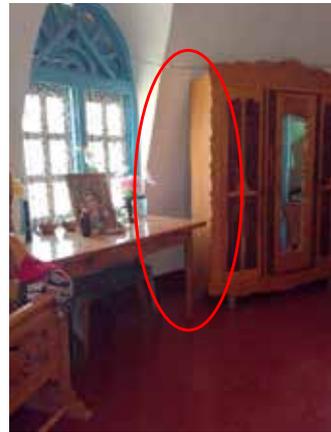
Figure 04: Unusable narrow corners of the living area.

As per the observations of the dome houses constructed at the tsunami resettlement site at Pottuvil, it was identified that there is a considerable issue on internal space arrangement of the houses. Due to the curved shape of the walls, and the circular shape of

the building, it creates unusable narrow corners inside the house. Also, the construction materials and the methods are not familiar with the relevant community. Not only that, but also the construction methods limited the possibility of future expansions of the housing units and it acts as a barrier for the future developments and the dreams of the occupants.

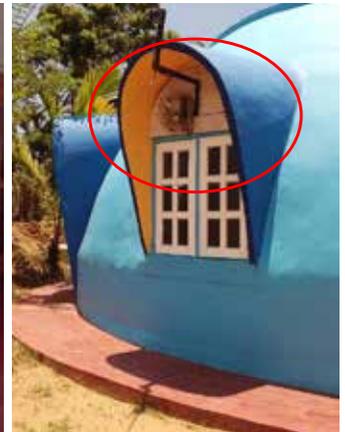
Figure 05: Covered the area allocated for permanent ventilation by using temporary materials.

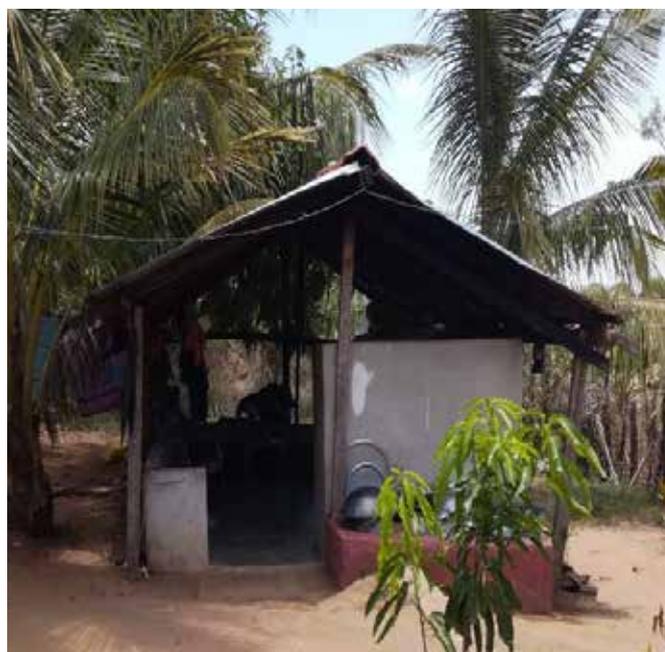
Figure 07: Detached kitchen

Further, it is observed that, several houses have a detached kitchen made out of commonly available materials with a typical gable roof form which are very familiar with the people. This shows the identity of the community and their actual needs of the houses. With all these issues, the social perceptions on the appearance of the building shape creates marginalized communities. Also, the setting out of the resettlement housing reflects an unplanned development pattern throughout the context. Visual and physical connectivity between each housing unit is very poor in condition.

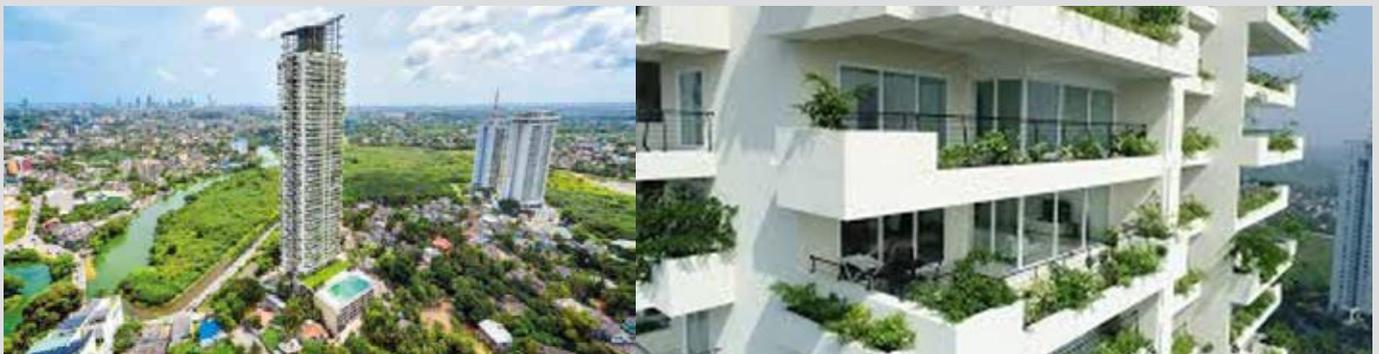
Located in Rajagiriya, Sri Lanka
 Architect- Milroy Perera Associates
 Contractor- Maga Engineering.
 Dubbed the ‘world’s tallest vertical garden’.
 Sri Lanka’s first sustainable high-rise apartment complex.

Plants growing in all 46 of its floors as a ‘green cover’, which acts as a natural cooling system. All apartments having a private garden terrace. Built up with a process to reduce carbon footprint and more importantly, reduce maintenance cost across the board.

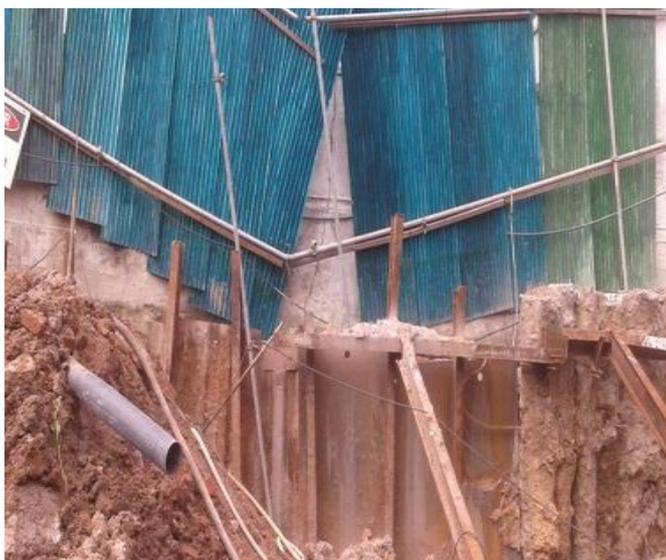
Figure 01: Effect of inadequate support system to neighboring structure.

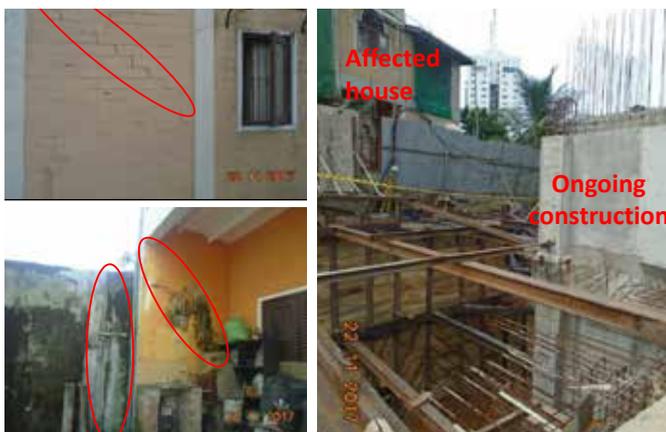
Source: NBRO/PMD/CR-161/2017

Figure 02: Development of cracks in adjacent structures due to inadequate earth retaining systems

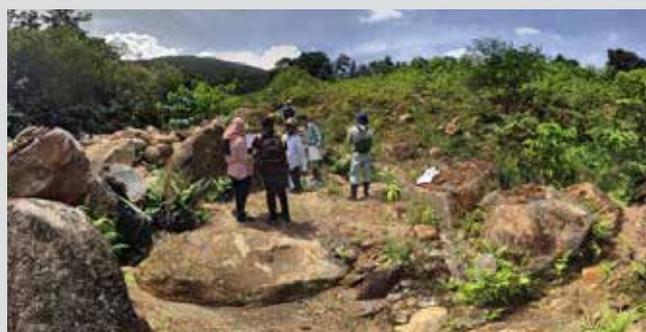
Field visit at Morawakkanda

Field investigation was carried out at Morawakkanda site on June 20-21 in order to verify the result of the debris flow simulation and yellow zone prepared on desk. The working team also verify the micro-topography and possible flow range of debris flow that cannot be identified in 1:10,000 scale map. Meanwhile, soil samples were collected for grain-size analysis in order to acquire the actual parameters which is used for the simulation instead of the tentative parameters. In addition, locations of the fully destroyed houses were collected, that information will be referred to set Red zone in the site specific hazard mapping.

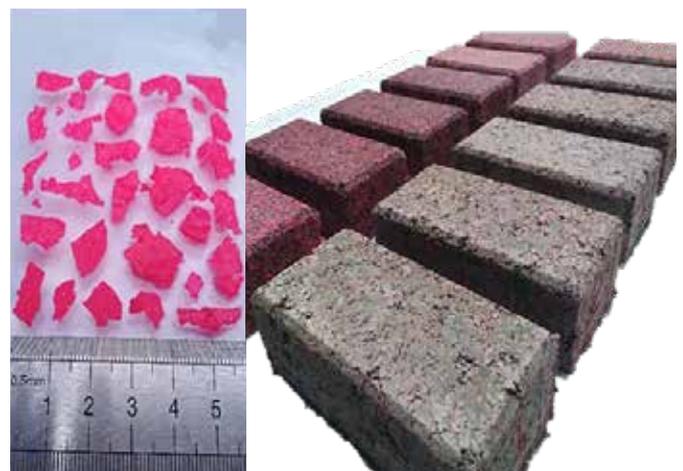
Small fabric pieces act as reinforcing fibers in the cement matrix. As a result of that failure pattern of this block is transforms to more ductile failure mode from conventional brittle failure mode which gives an indication on shock absorption capability of the fabric embedded paving block. Accordingly it is suggest that this paving block can be used for sports surfaces which gives better foot comfort.

In Sri Lanka synthetic fiber blended fabric offcuts considered as waste which create a significant waste disposal problem. Currently it is being sent to a cement manufacturing plant where it is incinerated as fuel in the cement kiln or it will be ended up with illegal dumping in land fillings. The better way to manage this waste is use of waste as a raw material for another industry considering environmental preservation. Accordingly paving block was developed with the use of fabric waste as a result of research activities. Fabric embedded paving blocks shows special features like water infiltration capability and shock absorption capability when compared with conventional cement based paving blocks. Water permeability of polyester spandex fabric embedded paving blocks is 100 times higher than that of commercially available cement based paving blocks. This feature leads to reduce surface runoff during raining while recharging underground water table. This will be the solution to reduce instant flooding on open concrete areas during heavy rain.
