N ewsletter

Published : October 2016

Technical Co-operation for Mitigation of Natural Disasters Due to Climate Change in Sri Lanka

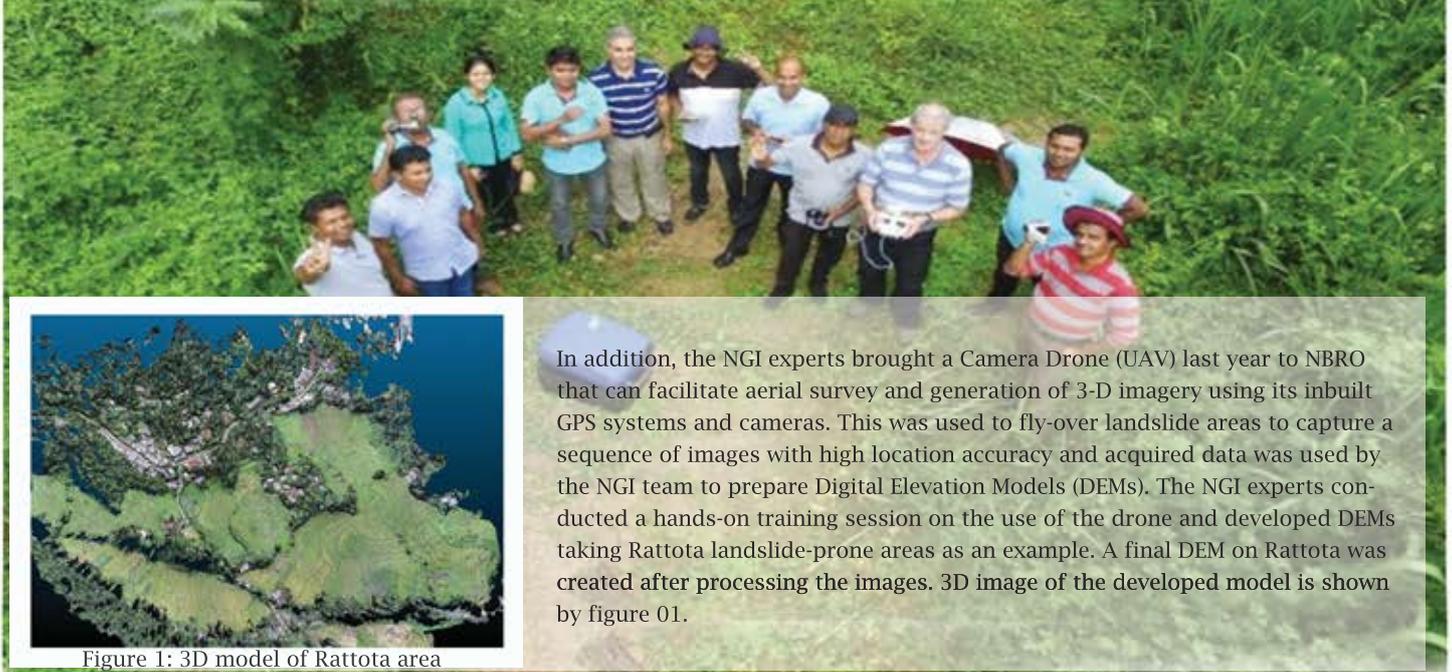
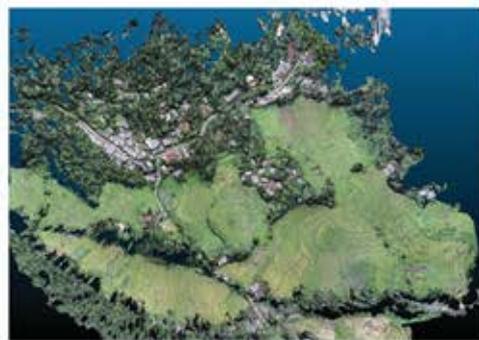
Figure 1: 3D model of Rattota area

In addition, the NGI experts brought a Camera Drone (UAV) last year to NBRO that can facilitate aerial survey and generation of 3-D imagery using its inbuilt GPS systems and cameras. This was used to fly-over landslide areas to capture a sequence of images with high location accuracy and acquired data was used by the NGI team to prepare Digital Elevation Models (DEMs). The NGI experts conducted a hands-on training session on the use of the drone and developed DEMs taking Rattota landslide-prone areas as an example. A final DEM on Rattota was created after processing the images. 3D image of the developed model is shown by figure 01.

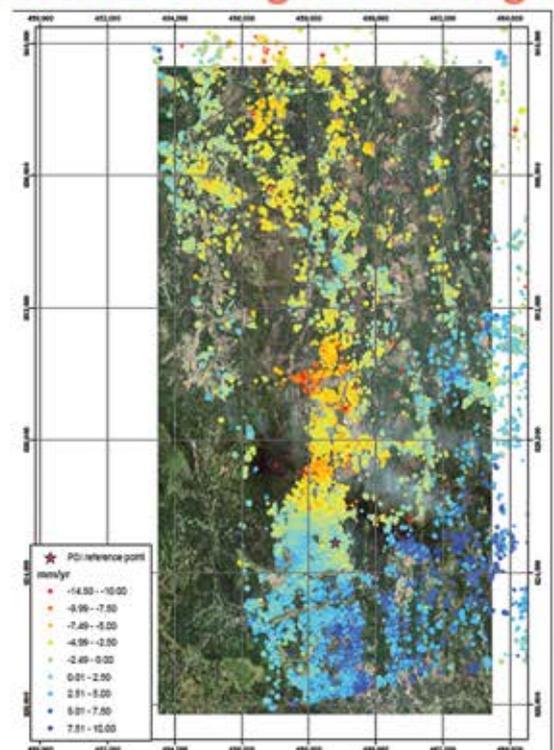
Figure 2: Deformation observed in 2014 from Persistent Scatterer points identified in the area of Matale MC

The distribution of Persistent Scatterer (PS) points within the study area is shown in Fig. 02 in which the scale gradating from yellow to dark red represents increasing deformation rates i.e. increasing ground subsidence rates. The colour scale indicating green and blue points are where there has been little or no change in the subsidence rate. PS with positive velocities indicated in blue colour shows the upward surface deformation motion where the subsidence rate has reversed, while negative deformation rates reflect movements downward where the subsidence is increasing.

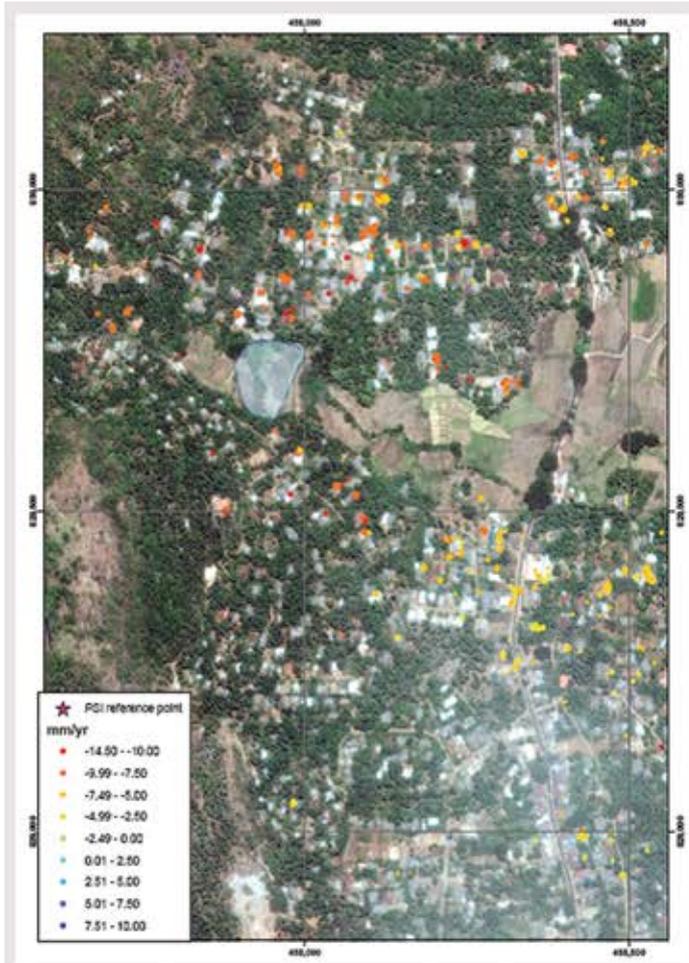
Figure 2. 1: Deformation observed in year 2014 for the PS identified in Matale MC area

PSI derived subsidence rates were found to be in the range from -14.50 to 10 mm/yr. The area of increasing subsidence is larger than that of decreasing subsidence. InSAR analysis reveals that the higher subsidence rates are in the central part of the study area.

The Subsidence Hazard Zonation map for Matale MC Area is shown by Fig. 2.1. This map was compiled by taking the results of SAR Interferometry survey, GPR survey and taking into consideration the Geological features of the area.

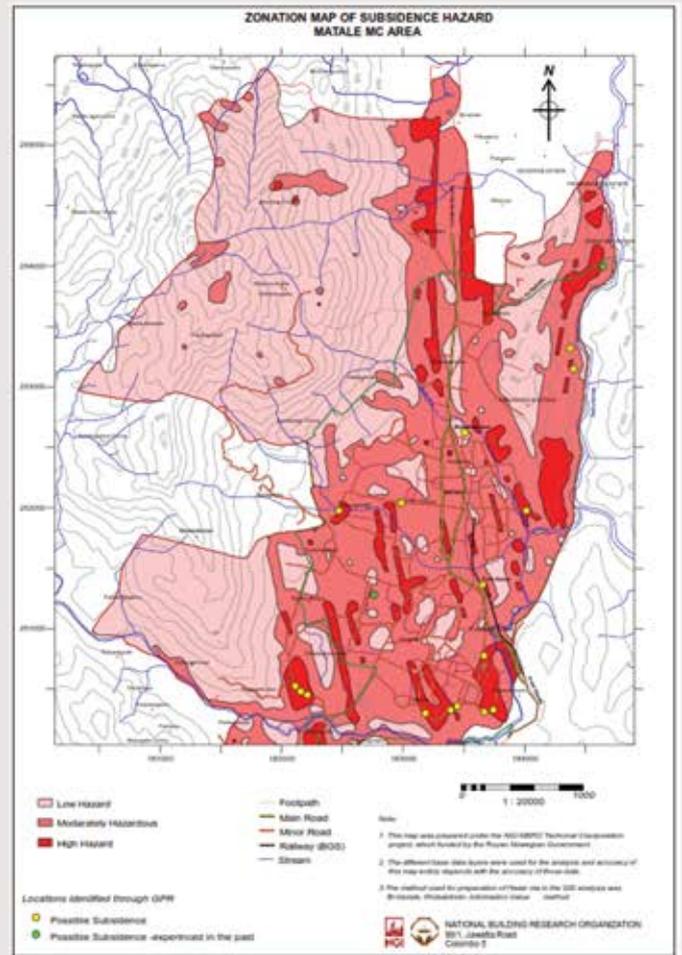
Figure 3: Zonation Map of Ground Subsidence Hazard in Matale MC Area

As shown in Fig. 3, the ground subsidence hazard zones range from low hazard areas in pink, through medium hazard areas in red, to areas of high hazard in dark red colour. Matale city center and its immediate vicinity marked in dark red indicate high hazard while Aluviharaya, Harasgama, Kalduwela and Dodamdeniya show low hazard level. Further, other locations identified as having the possibility of ground subsidence hazard are indicated by yellow and green colour points.

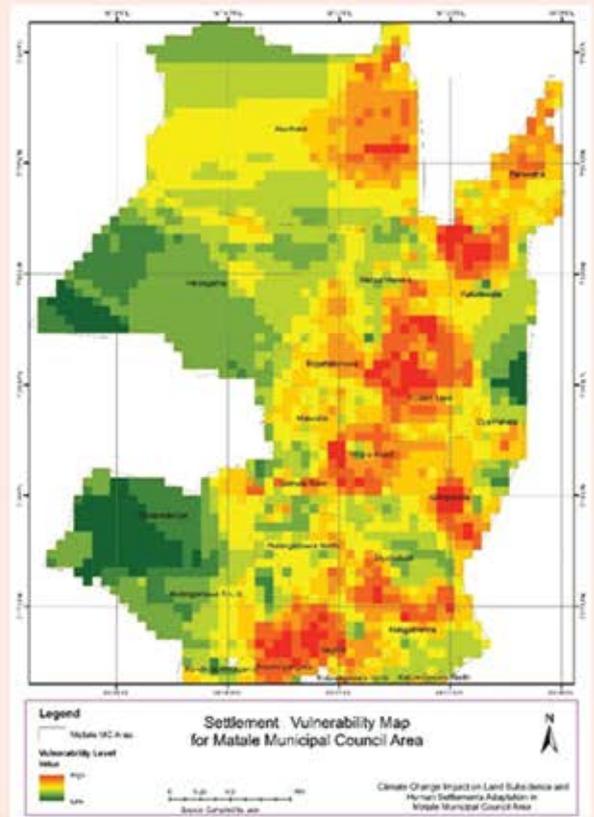
Figure 4: Map of settlement vulnerability for Matale MC Area based on primary and secondary data

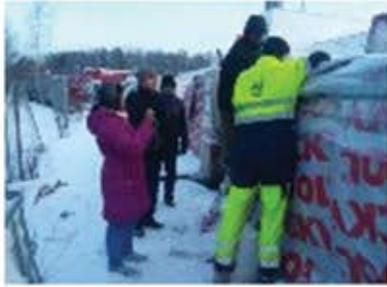
Study on oil contamination issues in groundwater and remedial measures

The field visit covered how NGI involves in site investigation, ground water monitoring, and remediation of contaminated soil, ground water and marine sediments.

NGI explained use of biological organisms in the remediation of oil contamination.

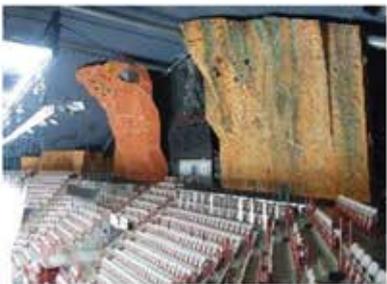
Geological formation in Indoor stadium/Olympic cavern hall

Norway's surface consists of exposed rock. The NGI has used this feature to convert a mountain cavern to a tunnel and a sport center. Olympic stadium at Lillehammer is constructed under an exposed rock. The stadium was built in

1991 and used in 1994 for Winter Olympics. Above the rock the team could observe several human settlements, stands without any risk.

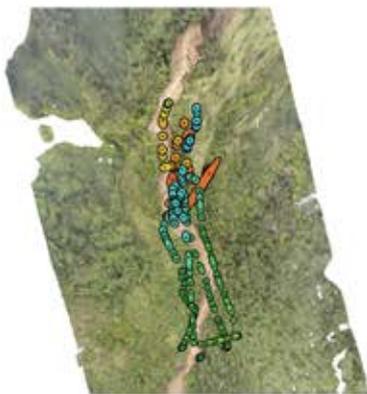
- 7.8832 m
- 6.30656 m
- 4.72992 m
- 3.15328 m
- 1.57664 m
- 0 m
- 1.57664 m
- 1.16328 m
- 1.72992 m
- 3.06656 m
- 4.8832 m

X error (m)	Y error (m)	Z error (m)	Total error (m)
1.799930	3.078669	3.438323	4.953788

Figure 6: Error Estimation in Landslide Area

The drone flow path details over the landslide and settlements are given below. The color variation shows the error estimation of the air photos. The average camera location errors at both locations were 5m.

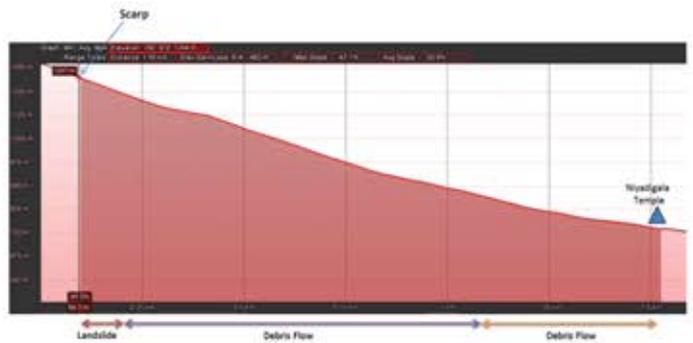
Figure 8: Slope variation in Landslide Path

The images were aligned to generate 3D models. DEM was derived based on the model. The cross sections of the impact area (before and after landslide) were generated.

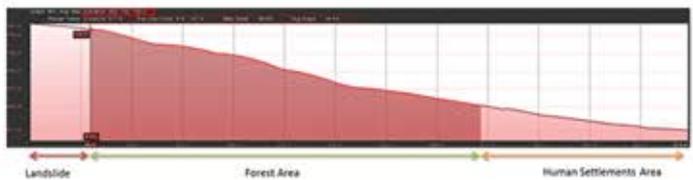
Figure 9: Slope variation from landslide to human settlement area

The average slope gradient from landslide to Niyadigala temple was 33%. Figure 9 illustrates the slope gradient from landslide to the temple. Another section was developed from deposit area to human settlement area as illustrated by Fig. 10 and the slope gradient was 18.5%. The distance from the deposit area to the nearest house along the valley is 600m.

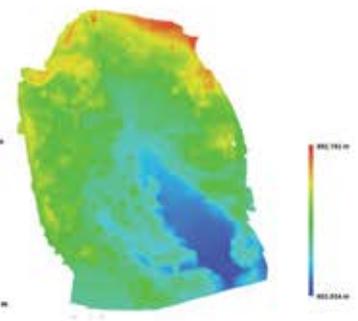
Figure 11: DEM - Settlement and Landslide area

Soil mass changes were calculated based on two DEMs shown in Fig. 10. In the map, blue colour represents soil loss areas, and yellow and red colours represent soil deposit areas. Maximum soil loss height was 64m and maximum soil deposit height was 6m.

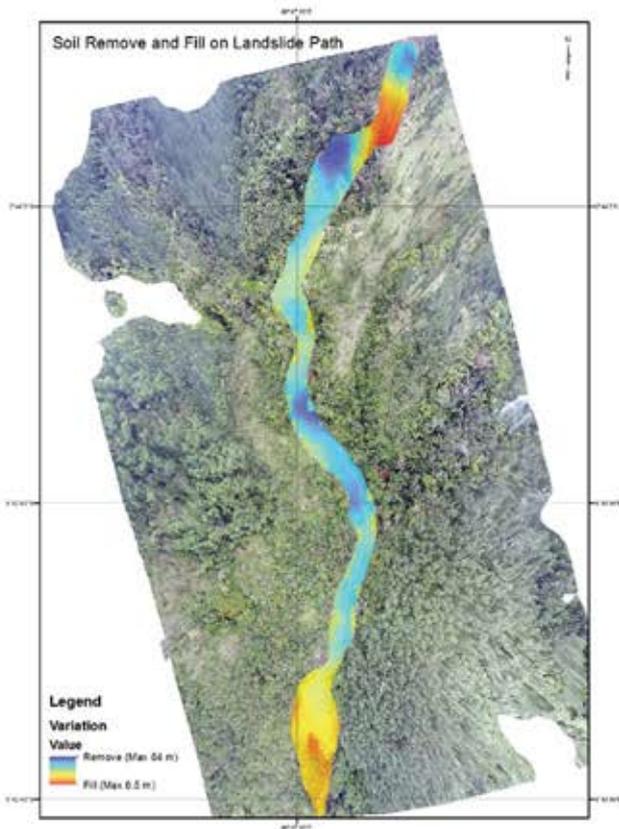
Figure 12: Soil loss and fill along the landslide path

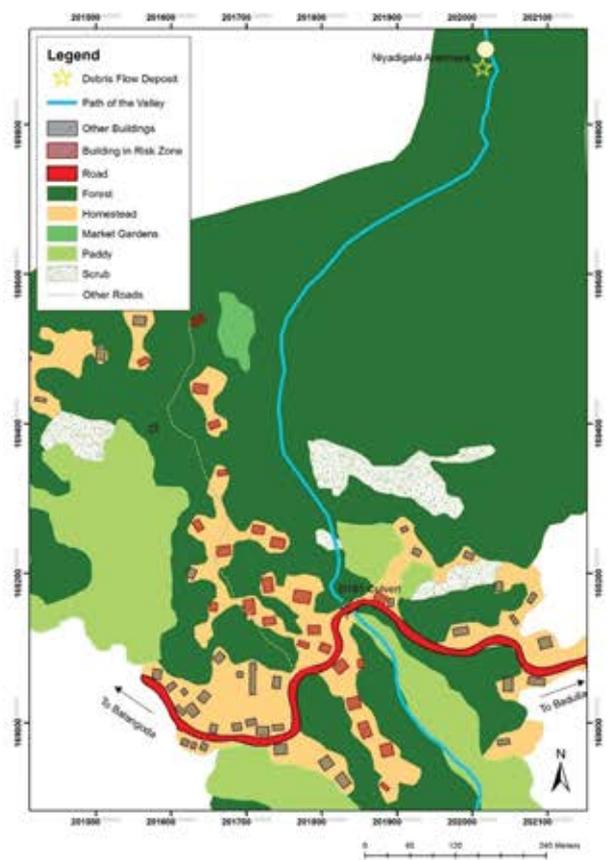
Figure 13: Layout map of the settlement area

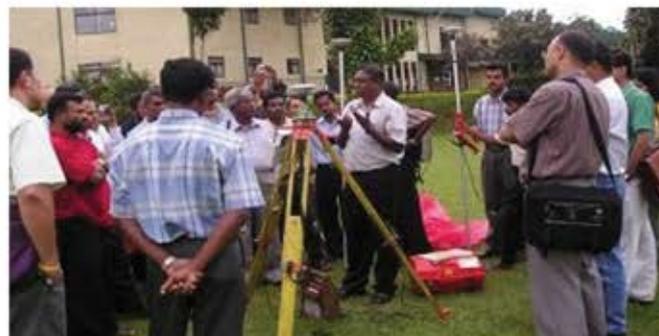
Field demonstration of mapping techniques during the field visit

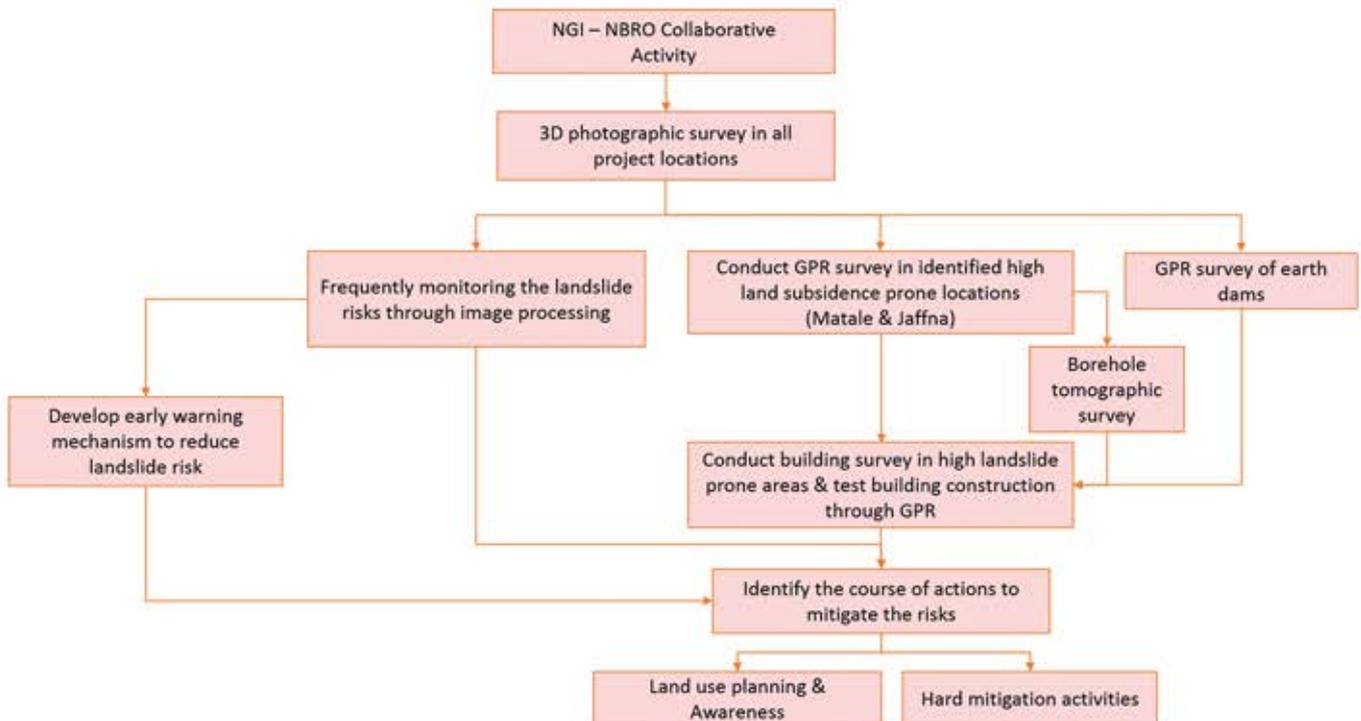
The comprehensive methodology of activities can be described by the following figure.
