# N Newsletter

Published : August 2016

## Long-Term Sustainability of Post-Disaster Housing Reconstruction Projects

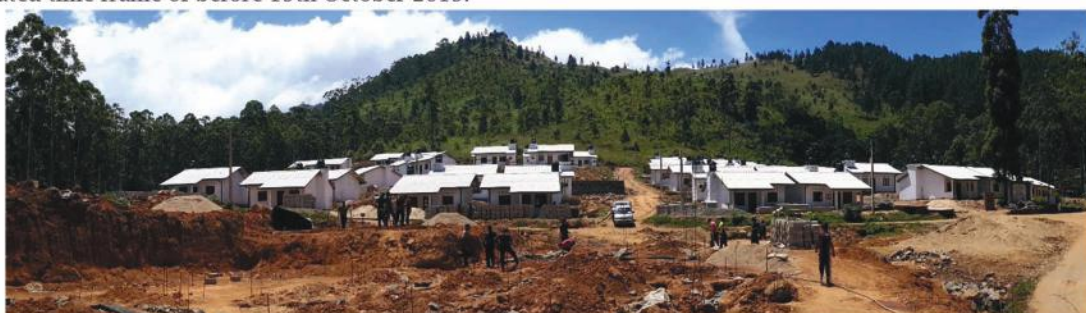
Panoramic view of the resettlements site by June 2016

Although, the above process and procedure were established at the apex level, the project could not be completed within the stipulated time frame and made the landslide victims to continue living in camps for almost 2 years after the landslide. Also, some issues were recorded; that could have caused a delay in the construction process, and are described with reference to rest of key components of the housing construction programme. Following picture gives the panoramic view of the resettlements site as in July 2016.

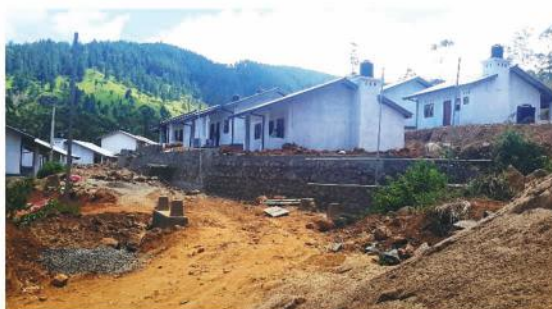
Progress of Mackaldeniya Poonagala Resettlement site by June 2016

In the site area acquired for resettlement, a variation in an average slope of angle from 0° to 30° is being observed and hence many precautions and extra work had to be considered specifically for this project. In addition to the general costs, several added works considered as such were the construction of the retaining walls, drainage systems for individual plots, elephant fences, and access steps that were added carried out in this project for completion.

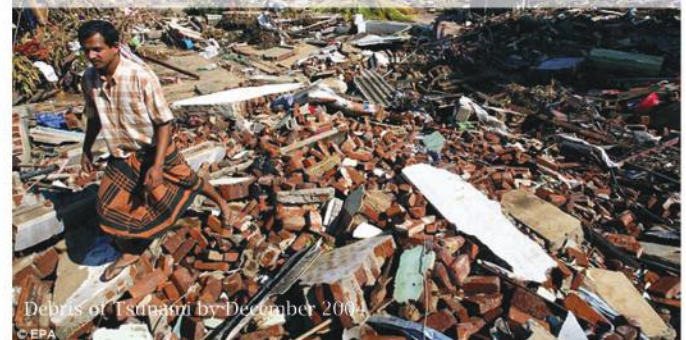
Figure: Houses Damaged due to Different Disaster Categories

Fully damaged houses recorded by tsunami is significant, which takes 46.9% out of other disaster events.

Disasters damaged and destroyed the properties which reduced the revenue of the country. Figure 9 shows the damages to houses due to different categories of disasters. Accordingly, most significant damage occurring to houses are caused by the disastrous wind events, floods and tsunami which shows 46.3 %, 36.3 %, and 13.8% respectively. Other important disaster types causing damage to houses are landslides. Furthermore, disasters such as lightning and drought have not caused damage to houses.

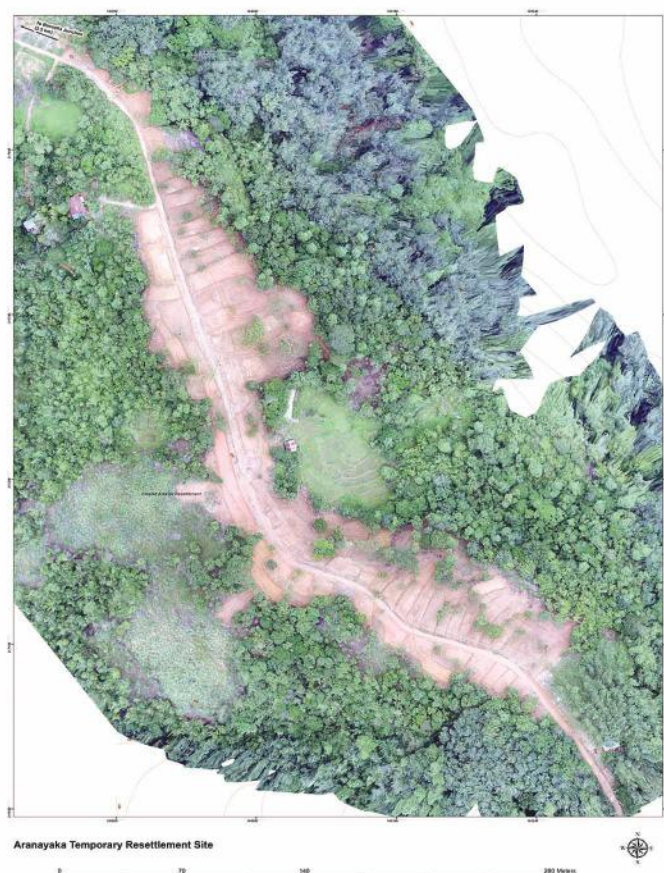
3D image of the resettlement site – as captured by drone

Choice of location, site selection and settlement planning are some of the crucial factors which determine the success or failure of a resettlement project. In a resettlement process, site selection and settlement planning may require extended time period due to associated time consuming works. Demarcation of site boundary, lay out planning and designing are some of the initial tasks that needs to be performed after the identification of a new location for resettlement. Amount of time and work needs to be undertaken mostly depend on the characteristics of the selected location. These tasks become more complex, when a site is in a hilly area. In general practice these tasks are performed by surveyors and planners with detailed site investigations. Specially in a planning resettlement site, placement of houses, internal road system, drainage system and open spaces are needed to be planned carefully based on the building regulations. Survey plans and contour plans are essential for preparing these plans in larger scale. Further, study on surrounding areas of the selected land and their land uses is essential. These studies are often conducted by using the land use maps of survey department. However, due to unavailability of large scale land use maps, site specific land use maps are created using satellite images in most cases.

National Building Research Organisation (NBRO) as the technical arm of the Ministry of Disaster Management, has stepped in to the use of drone technology for planning and designing of resettlement sites. NBRO initiated this task as a pilot study for a resettlement site at Aranayaka divisional secretariat division. NBRO flew its own drone at Kalugala resettlement site of Aranayaka for this purpose. It took only 20 minutes to capture the images of the resettlement land and surrounding areas. Captured images were used to create 3D image of the area which was taken used to generate contour map and land use map within a half day of work time. Further, 3D image was used to demarcate the exact areas of the resettlement which has been used to draft a layout plan of the site. All these tasks which are highly time consuming and complex in nature, could be completed within two days time with the use of drone technology. NBRO, with the newly acquired knowledge and experience, is planning to extend the application of drone technology to the field of hazard assessment, risk assessment, risk monitoring, land use planning etc.
