# NBRO Newsletter

A Special Edition on NBRO 2019 Highlights

VOLUME: 45 | December 2019

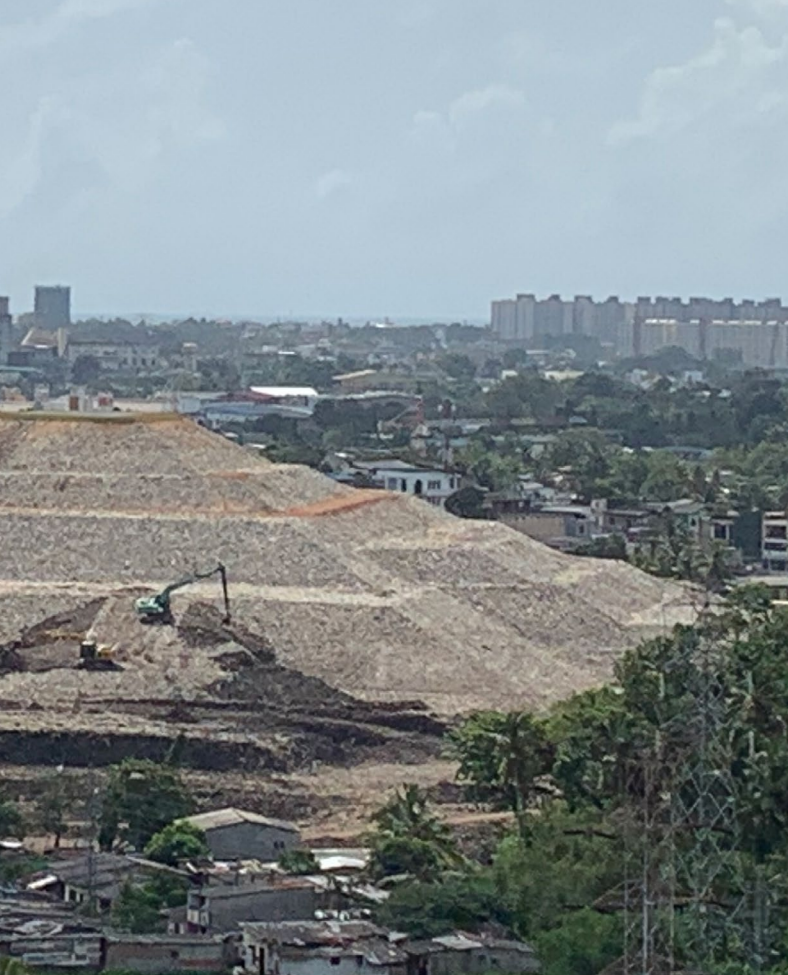
*Fig. 1: During Rehabilitation Process*

Soon after the disaster, a team of experts of National Building Research Organisation (NBRO) visited the site to investigate the existing situation, and to elucidate the probable cause of failure, and also to identify in remedial actions to prevent a further catastrophe. Government of Sri Lanka later decided to rehabilitate and develop the waste dump as a recreational area and commenced a rehabilitation program since year 2017. Consequently, NBRO has been providing guidance and consultancies on ;

(1). Slope stability and compaction processes by ensuring the achievement of targets of mitigation measures in accordance with proposed design and specifications. In addition, NBRO is also tackling possible construction issues and recommending technical solutions in collaboration with the client. Full time supervision of construction work

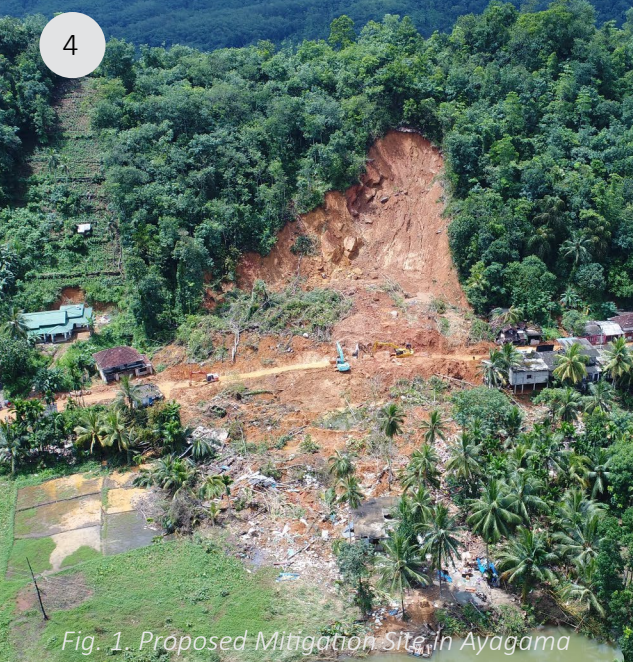
Fig. 1. Proposed Mitigation Site in Ayagama

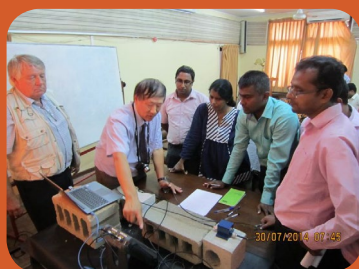
Fig. 1: GPR Demostration

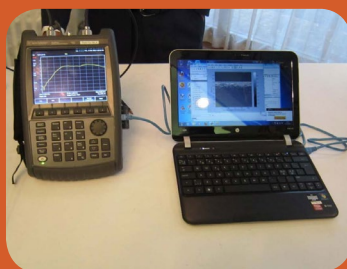
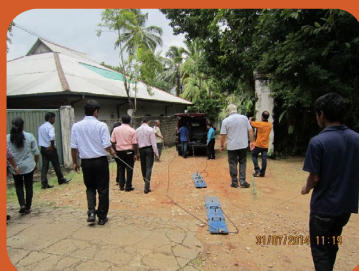
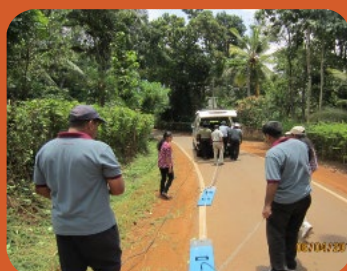
Fig. 2: GPR Field Surveys

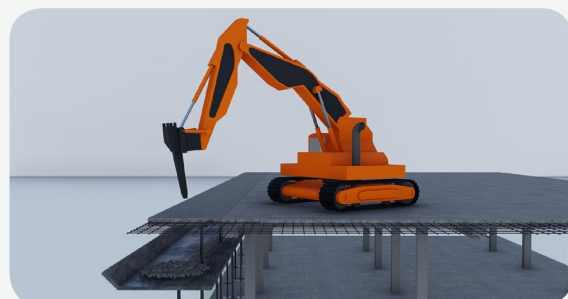
Fig. 1: Demolition Work Using Machinery

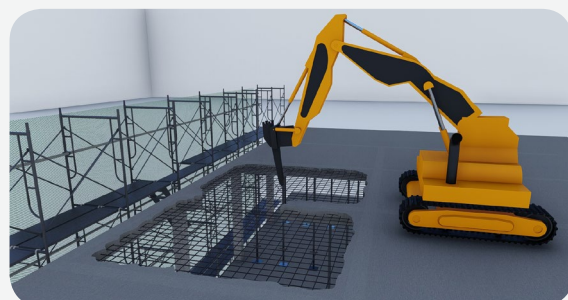
Fig. 2: Demolition Work Using Machinery

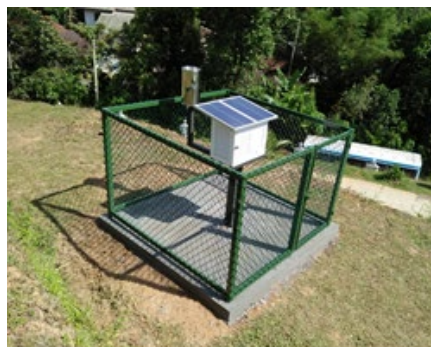
Fig.1: Automated rain gauge station

As the national focal point for landslide risk management, NBRO conducts identification, investigation, hazard mapping, monitoring, early warning and mitigation of landslides in the country. Rainfall is the main triggering factor for the landslide occurrences in Sri Lanka. Issuing landslide warnings is in two scales; either on a "regional-scale" (large scale) or "site-specific". In regional-scale; forecasting and issuing general warnings are relying on the rainfall measurements/predictions of triggering event. In site specific scale; forecasting and issuing warnings rely on the measurements of the monitored landslide locations (limited to the monitored Landslides).

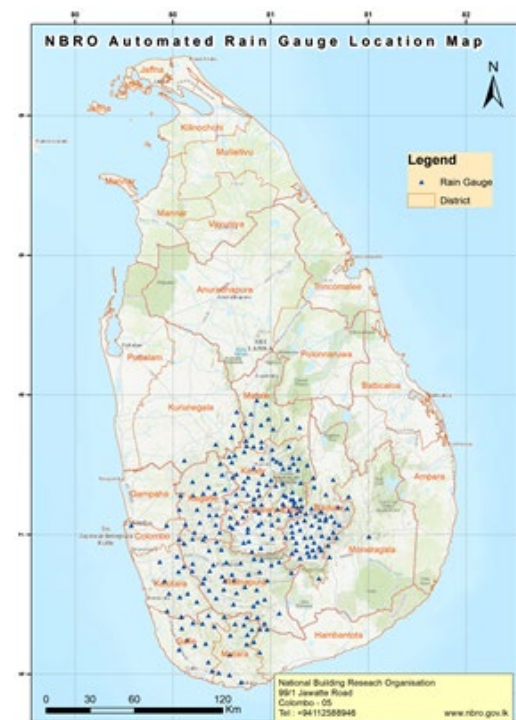
Fig.2: Distribution of Automated Rain-fall Gauge stations

Level 1 (Yellow)	Level 2 (Amber)	Level 3 (Red)
<b>Watch</b> <b>75 mm/day</b>		
<b>Alert</b> <b>100mm/day</b>		
<b>Evacuation, Off limit 75 mm/hour or 150mm/day</b>

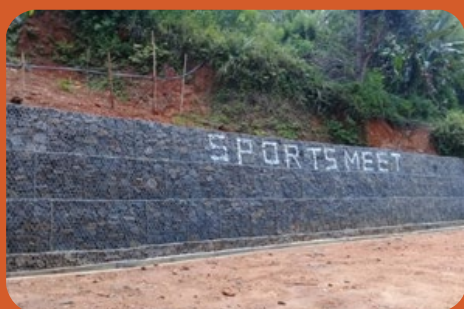
Fig.1: Lankagama Kanishta Vidyalyaya

During the last few years more than 35 sites including public places such as hospital, schools, villages and sites along the major roads (Figure 01, and 02) have been mitigated within the above landslide prone districts under the above project. The following eight locations have been selected to conduct landslide mitigations activities in this year 2019.

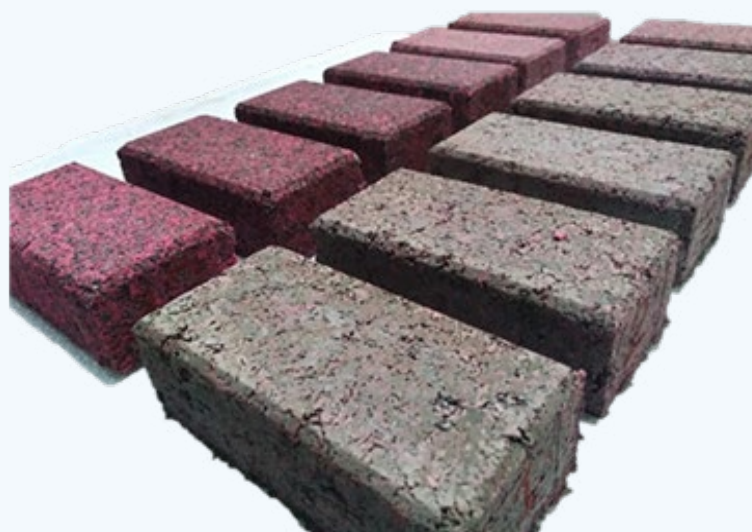
Fig. 1. Fabric Embedded Paving blocks

In Sri Lanka synthetic fiber blended fabric offcuts considered as waste, creates a significant waste disposal problem. Currently it is being sent to a cement manufacturing plant where it is incinerated as fuel in the cement kiln or it will end up with illegal dumping in land fillings. Accordingly paving block was developed with the use of fabric waste as a result of research activities. Fabric embedded paving blocks shows special features like water infiltration capability and shock absorption capability when compared with conventional cement based paving blocks. Water permeability of polyester spandex fabric embedded paving blocks is 100 times higher than that of commercially available cement based paving blocks. This feature leads to reduce surface runoff during raining while recharging underground water table. This will be the solution to reduce instant flooding on open concrete areas during heavy rain.

The developed blocks were tested for shock absorption capability and its test results showed that force reduction percentage of fabric embedded paving blocks varies from 9% to 12%. Therefore, it is suggested that this paving block can be used for foot paths which gives better walking comfort.

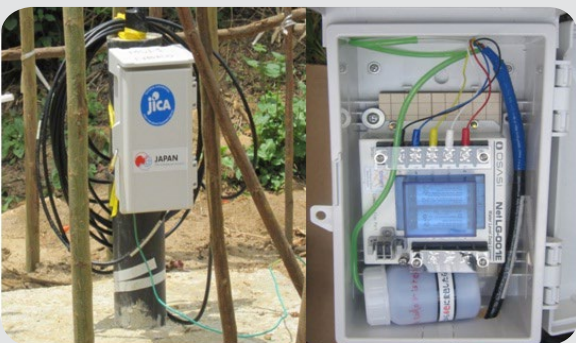
Fig. 1. Piezometer

1. The system transmit measurement data taken by observation instruments such as ground surface extensometers and rain gauges, installed in landslide risk areas to a management office located at a distance, in real time
2. The system monitors the onsite condition, evaluates the risk of landslide/slope failure and informs local residents of the risk at an early stage and urges them to evacuate.
3. The system is composed of observation instruments install on a slope (Ground surface extensometers, rain gauges, ground water gauges, strain gauges and multipoint inclinometers) and networking equipment (Radio transmitter, Communication devices, alarm devices and cloud service)

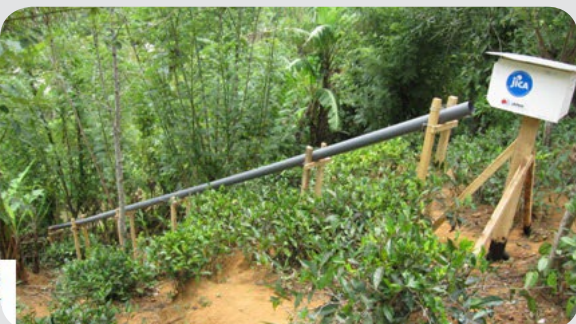
Fig. 2. Extensometer

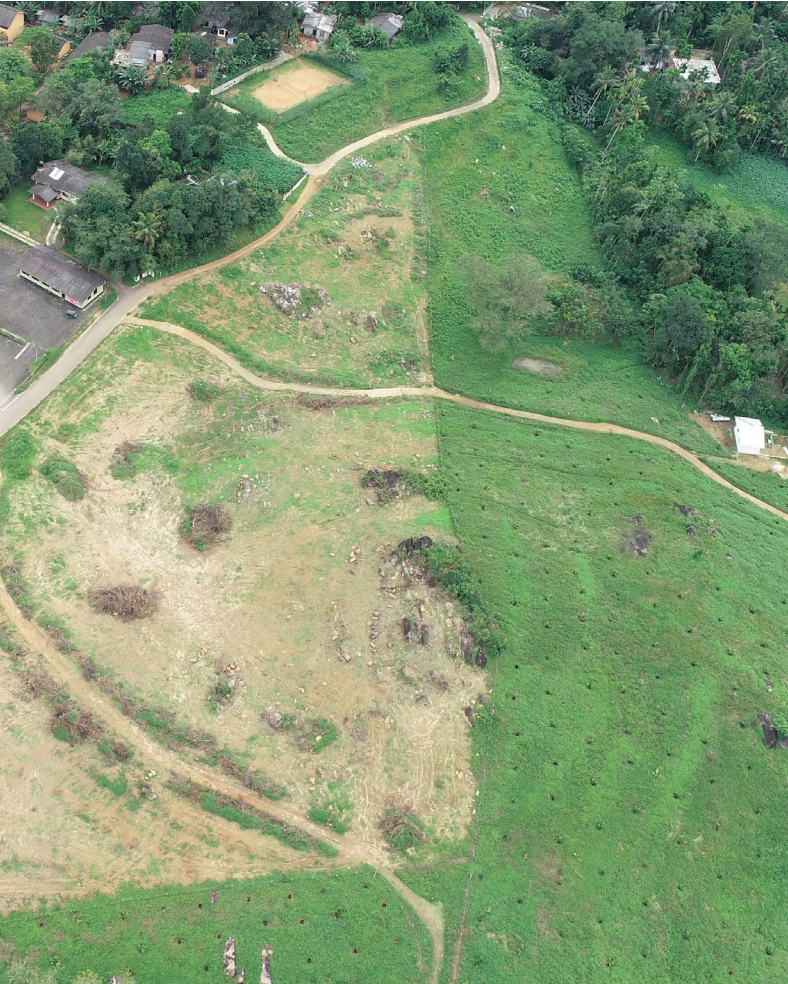
*Drone Image: "Mirishena Resettlement Site of the Bulathsinhala DSD of Kalutara District. 42 houses are proposed to be constructed within 4 acres of the land. Capture date - 3<sup>rd</sup> December 2019.*

The Ministry of Public Administration, Disaster Management and Livestock Development employed M/s Yapka Construction (Private) Limited as the contractor of this project and appointed National Building Research Organisation as the Implementation Agency. As the initial step, the contractor has commenced the site clearance and construction work in 3 sites namely, Pimburaawatta, Mirishena and Halwathura.
