Building Infrastructure Resilient to Disasters

ABSTRACT: This paper discusses impacts of disasters on infrastructure and counter measures that can be adopted in mitigating their impacts. Landslides, floods, tsunamis, and earthquakes are several major disasters that occur throughout the world, causing great destructions to infrastructure. Disaster mitigation, the first stage in disaster management, is the measures taken to minimize the impact of disasters. Slope stabilization, retaining walls for landslide mitigation; construction of floodways and flood prone buildings to control flooding; construction of seawalls to reduce the impact of tsunami run-up; and design and detailing of structures to be earthquake resistance are some methods that can be implemented in building disaster resilient infrastructure systems.

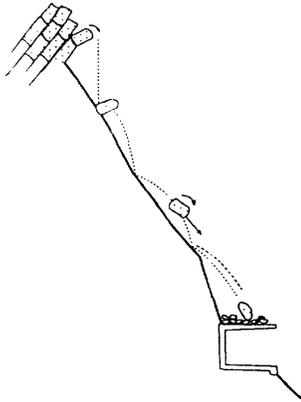
Fig 01 Movement of free falling blocks (Descoedres et al.1999)

steep rock wall or a cliff” (Descoedres et al.1999). The movement of the block may also be bouncing, rolling, and sliding as seen in Figure 1.

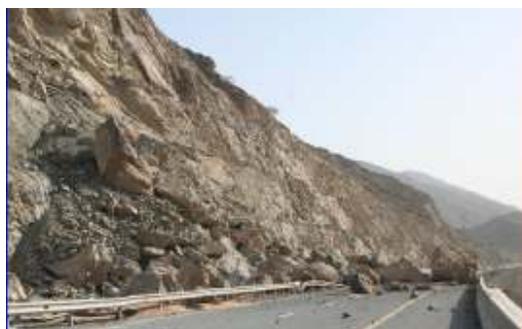
Fig 02 Rockfall onto a highway

Rockfalls are common in mountainous areas, especially in areas where road construction has resulted in destabilizing the cut slope, as shown in Figure 2.

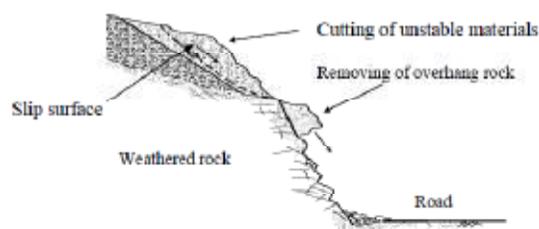
Fig 03 Treatment for cut slope failure of rock mass

A cut slope with unstable rock mass can be treated by modifying the slope geometry. In order to reduce the load and the shear force, unstable soil or rock mass can be removed from the head of an unstable slope as shown in Figure 3.

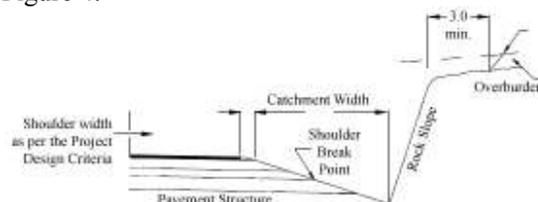
Fig 04 Typical cross section for safe rock slope

In highway construction, rock slopes are designed with a rock fall catchment area to prevent rock fall originating from the slope above the highway from reaching the highway lanes. Wider catchment in conjunction with appropriate geometry in general, equates to improved catchment reliability. According to the design standards, Ministry of Transport and highways, British Columbia, the recommended preliminary/conceptual catchment design to prevent rock fall onto the highway is shown in Figure 4.

Table 1 Recommended catchment width and depth for different rock slope heights

Rock cut height (m)	Catchment width (m)	Catchment depth (m)
up to 8 m	3 m	0.75 m
8 m to 16 m	4 m	1.00 m
over 16 m	5 m	1.25 m

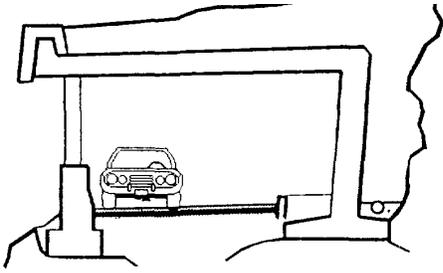
Fig 05 Schematic of rock shed (Descocudres et al. 1999)

However, for high rock cuts, catchment width that would successfully retain all rockfall from reaching highway lanes is considered excessively expensive. In such a situation, other mitigation methods such as benches or ditches in slopes can be used to stop the falling blocks together with appropriate catchment width. Along with the ditches, barriers and flexible wire net systems may be placed. Furthermore, rock sheds and reinforced retaining structures can absorb the energy of the falling rocks which helps reduce the impact of the rocks. Rock sheds are concrete structures covered in an absorbing material as seen in the following Figure 5.

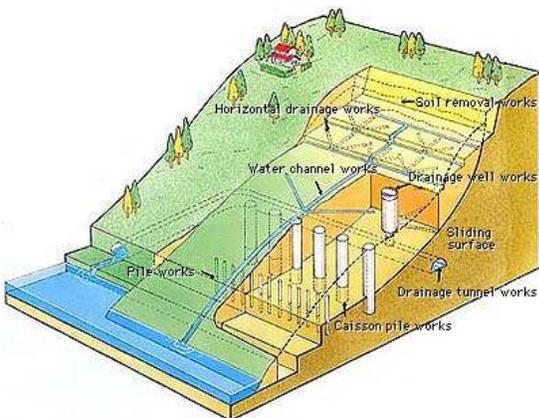
Fig 06 Landslide mitigation methods

These control methods include prevention and deterrent work. The purpose of prevention work is to stop or prevent landslide movement by changing natural conditions, such as topography, geology, and groundwater condition. On the other hand, the purpose of deterrent works is to deter part or all of landslide movement with structures. The application of the above methods for landslide mitigation is schematically shown in Figure 6.

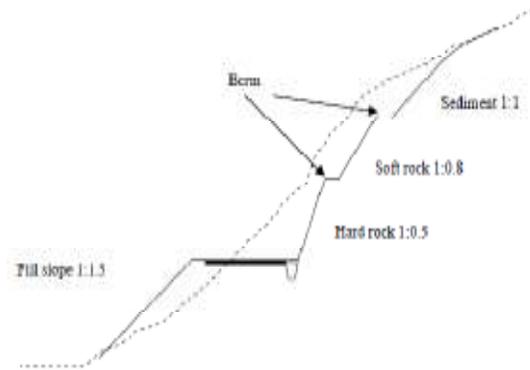
Fig 07 Ground conditions and shape of cut slope

The recommended standard maximum slope gradient for cut slope with different ground conditions is shown in Figure 7. However, the gradient indicated in Figure 7 is only indicative and detailed assessment and design of cut slopes should be carried out by considering the actual site condition.

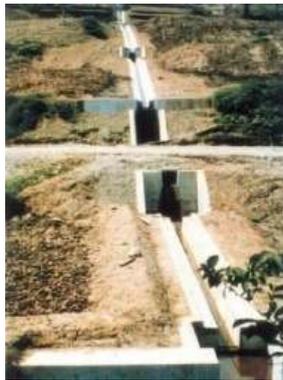
Fig 08 Surface drainage ditches (Popescu&Sasahara 2010)

A properly designed surface drainage network has to be constructed in order to prevent surface runoff water from springs and rainfall infiltrating the slopes and/or landslide area to avoid increase in pore water pressure. The surface water can be removed from the unstable slope by using a surface drainage system which comprises of cut off drain, berm drain, toe drain, drainage channels, and cascades (Figure 8).

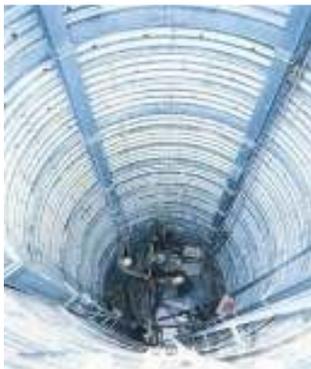
Fig 09 Wells for ground water drainage (Popescu&Sasahara 2010)

When lowering of ground water level is required in order to stabilize the slope, subsurface drains are constructed. In such cases, the ground water table is lowered by installation of horizontal drain, vertical drains, trench drains, drainage wells (Figure 9), drainage tunnels, inclined drains by directional drilling etc.

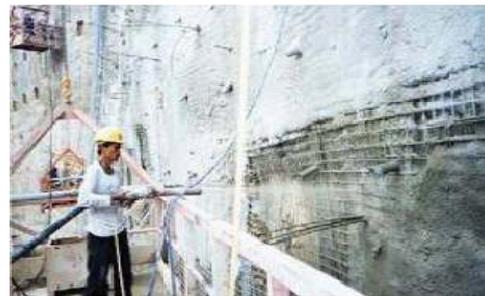
Fig 10 Soil nailing

Soil nailing and anchoring have been widely used in the stabilization of cut slopes, especially in the construction of highways and roads, where limited building space is available. Also these methods create the minimum disturbance to the natural slope and can be used as internal soil reinforcement measures in reducing the susceptibility of certain land areas to landslides. Soil nailing is a stabilization method of reinforcing existing soil by installing threaded steel bars into the slope or cut as construction proceeds from the top down. Grouted bars are installed to create a stable mass of soil and build a solid wall as shown in Figures 10 and 11.

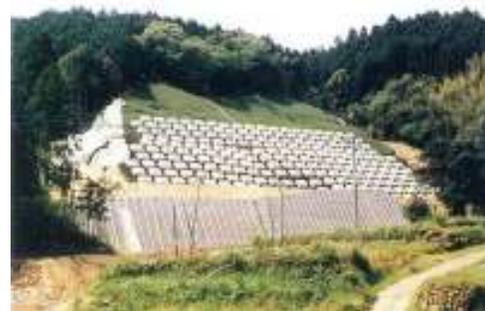
Fig 11 Soil anchoring for slope stabilization

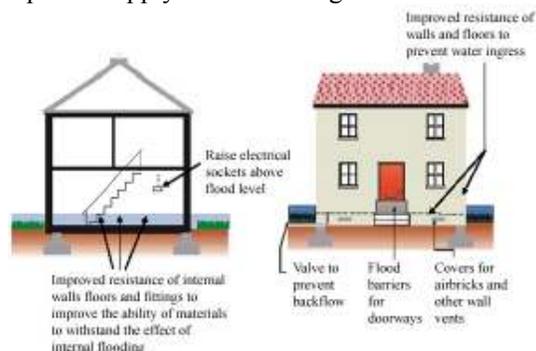
Fig 13 Construction techniques for flood resistant buildings (Planning and Building Standards Advice on Flooding 2006)

Several other guidelines that are suggested by the United Nations report on flood protection concerning buildings are as follows and can be illustrated in Figure13 (Vischer 1999);

- Hood-proof design of buildings typically on small earth pourings, on piers or behind local embankments.
- Omission of basements or addition of seals for entrances, light and airsupplies.

- Structural means against erosion and water pressure, including buoyancy.
- Improvement of flood resistance of water and power supply to the buildings.

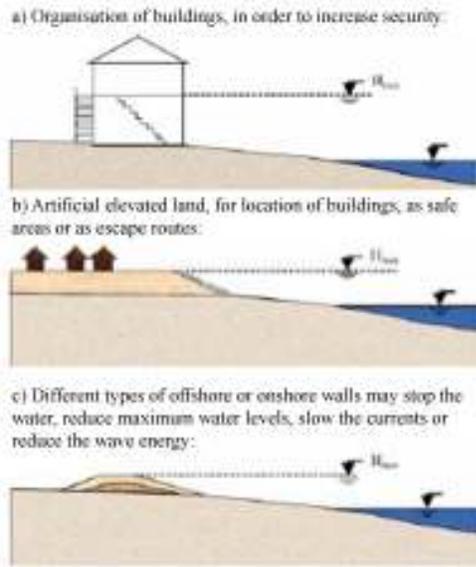
Fig 14 Possible tsunami mitigation strategies (Tsunami Risk Mitigation Strategy for Thailand 2006)

The construction of offshore or onshore barriers may help reduce inundation, water levels, wave energy that can be released on land, and wave speed, which are factors determining the degree of the impact of a tsunami (Tsunami Risk Mitigation Strategy for Thailand 2006).

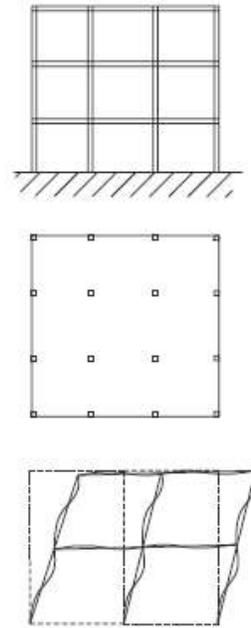
Fig 15 Elevation, plan and deformed shape of moment resisting frame (Szakats 2006)

Well detailed structures are the solution to resisting earthquake loads. Detailing all structures to perform in a ductile manner, which is the ability of a structure to “sustain its load and dissipate energy for several load cycles after initial yield” (Szakats 2006), prevents abrupt failures of structures, which are most destructive. Lateral loads can effectively be resisted utilizing shear walls, moment resisting frames, or braced frames (Figures 15, 16, and 17).

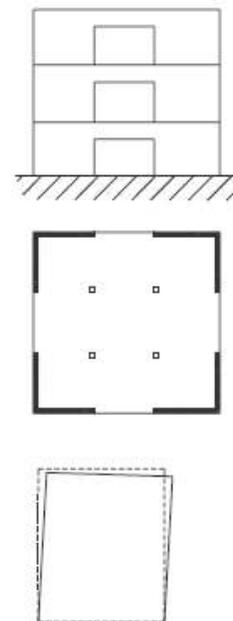
Fig 16 Elevation, plan and deformed shape of shear wall system (Szakats 2006)

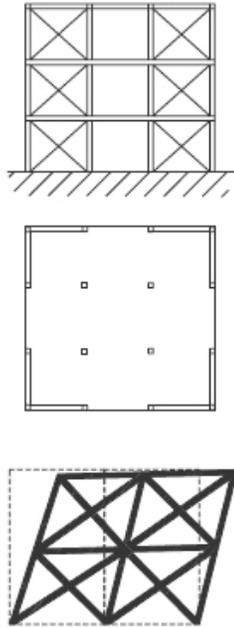
Fig 17 Elevation, plan, and deformed shape of cross braced frame (Szakats 2006)

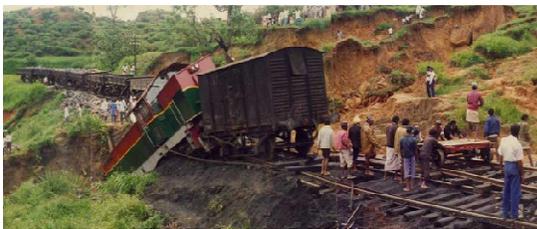
Fig18 Damage to the railway track

Watawala landslide occurred in June 1992 damaging nearly 100 m length of the Colombo-Badulla railway track between Galboda and Watawala.

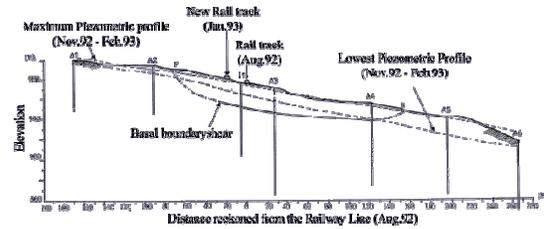
Fig 19 Longitudinal section of Watawala landslide (Rajaratnam & Bandari 1994)

The landslide was found to cover an area of approximately 22,920 m² and about 322,700 m³ slide volume. A typical longitudinal section of the landslide is shown in Figure 19.

- The Watawala landslide formed as well developed boundary shears involving nearly 25m depth of colluvium at the deepest point. The entire slide mass was found to lie within the colluvium, overlying highly weathered rock.

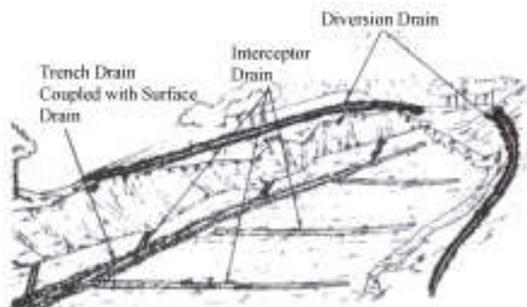
Fig 20 Typical Surface drainage system

The results clearly show that remedy lies in very effectively draining the slope so as to lower the piezometric profile. Unless that is done, the earth slide movements would continue to repeat year after year and if new thrusts develop in the head region of the earth slide and if instability of slide toe grows, it may expand in dimension both laterally as well as depth wise. Protection of toe of the earth slide was therefore absolutely essential, if the slide was to be contained. The mitigation of Watawla-landslide was associated with subsurface and surface drainage system. A typical surface and subsurface drainage system is given in Figures 20 and 21.

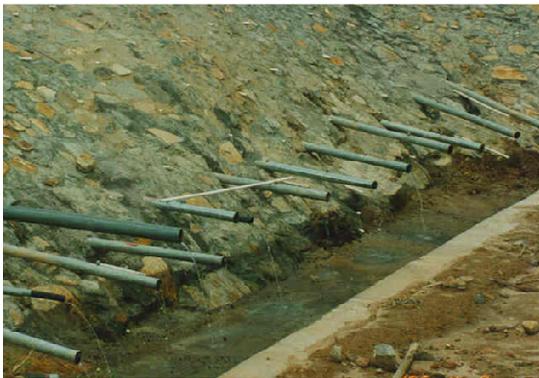
Fig 21 Sub surface drainage system

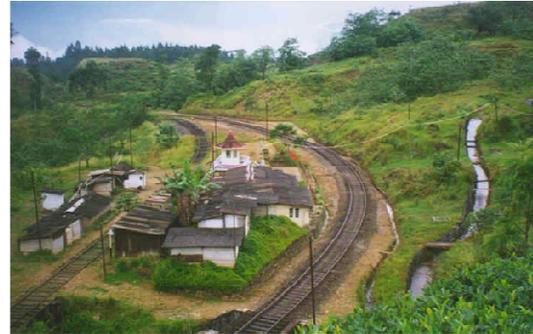
Figure 22 Present situation at Watawala after mitigation

With the installation of a proper surface and subsurface drainage system it was possible to stabilize the Watawalalandslide and for the last 18years, theColombo-Badullatrain haspassed through this area without any disruptions (Figure 22).

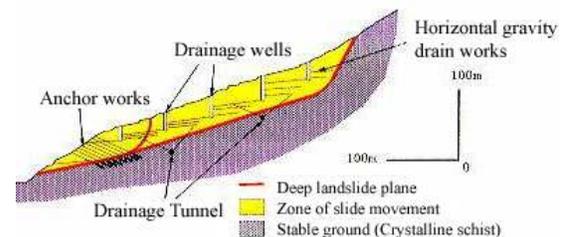
Figure 23 Cross section of Yuzurihara landslide with typical drainage (The Japan Landslide Society)

Eleven units of drainage borings works, 20 water catchment wells, and two drainage tunnels of length 683m and 541m, have currently been implemented in the prevention area of Yuzurihara (Popescu& Sasahara 2010). The effectiveness of these counter measures have also been monitored by conducting stability analyses, ground movement measurements, and ground water level measurements, each year. The stability analyses have confirmed that the slides have become inactive after the implementation of the mitigation procedures. A schematic of the implemented measures is shown in Figure 23.
