INNOVATION GEARED
BUILDING RESILIENCE

National Building Research Organisation
11th Annual Research
Symposium 2021

Proceedings of
11th Annual Research Symposium - 2021
Innovation Geared Building Resilience

14th & 15th December, 2021
Waters Edge, Battaramulla

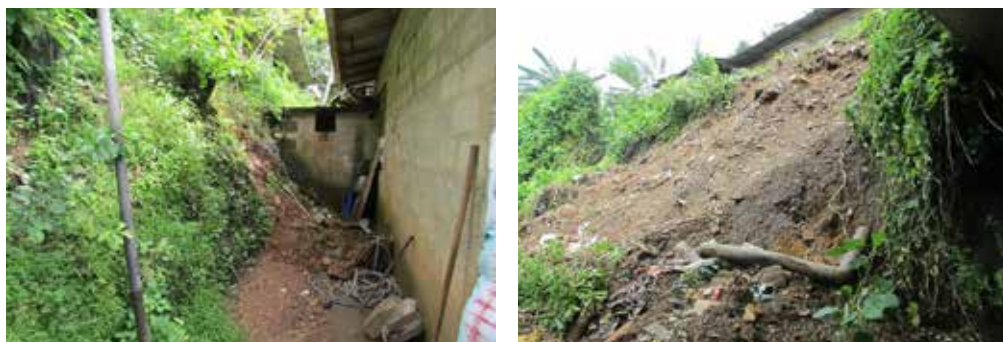
Figure 03: Photographs showing cut slope failures in the Bogahawaththa landfill

The study area is 0.83 hectares consisting of 38 abodes with 29 permanent and 9 temporary subordinate structures. The area of the failure is cut slope around 200 m in length and 28 m in width. The height of the cut slope is between 4 m to 12.5 m. The average annual rainfall of the area is about 2500 mm - 3000 mm as this area belongs to the wet zone of the island. As the result of the northwest monsoon, several catastrophic cut slope failures occurred on 13th May 2021 where 150 mm of daily rainfall was recorded. The geology of the area consists of Charnockitic gneiss.

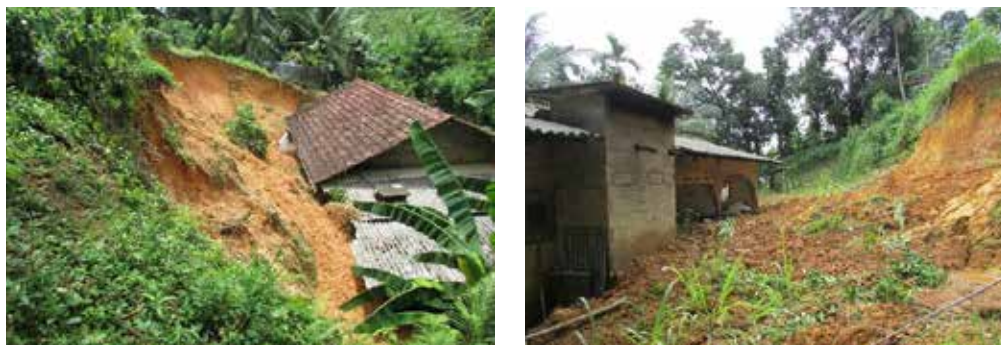
Figure 02: Several cutting failures and destruction caused in Nagoda DSD

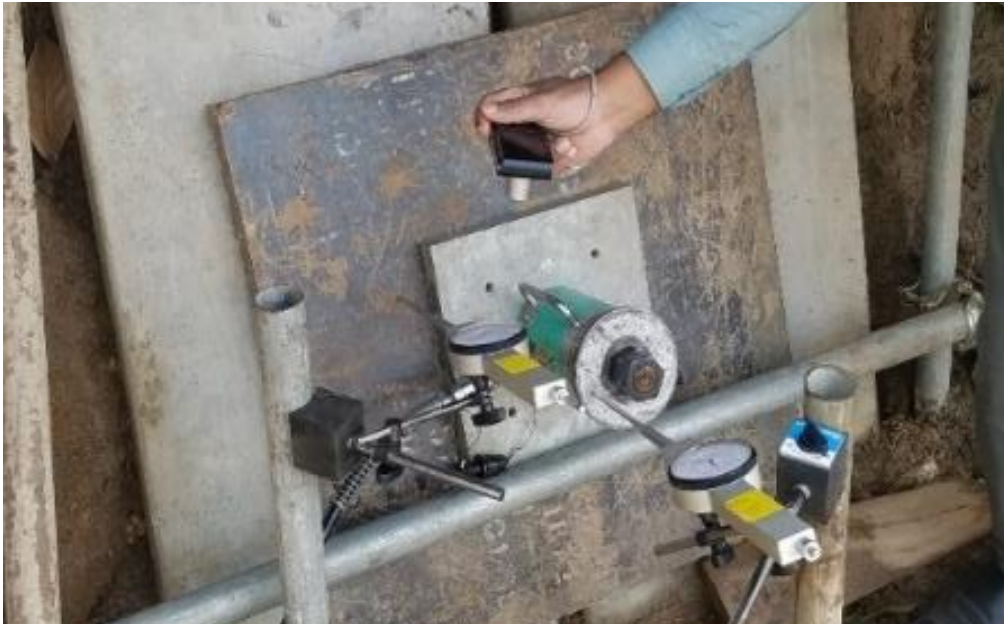
Figure 01 : Pull-out test Arrangement

The nail that is used for the pull-out test should be installed according to the methods that are used for the working nails. In Sri Lanka, the typical grouted length is 2m.

Materials and equipment were used for the pull-out test at each site can be identified as Calibrated hollow plunger jack that has 60 tonnes or 120 tonnes maximum capacity complete with hydraulic pump, pressure gauge etc. Calibrated dial gauges with 150 mm stem travel and readable to 0.05 mm, Reference frame for setting the dial gauge, supporting system to retain the jack in position, Tools for preparation of ground to erect the testing arrangement.

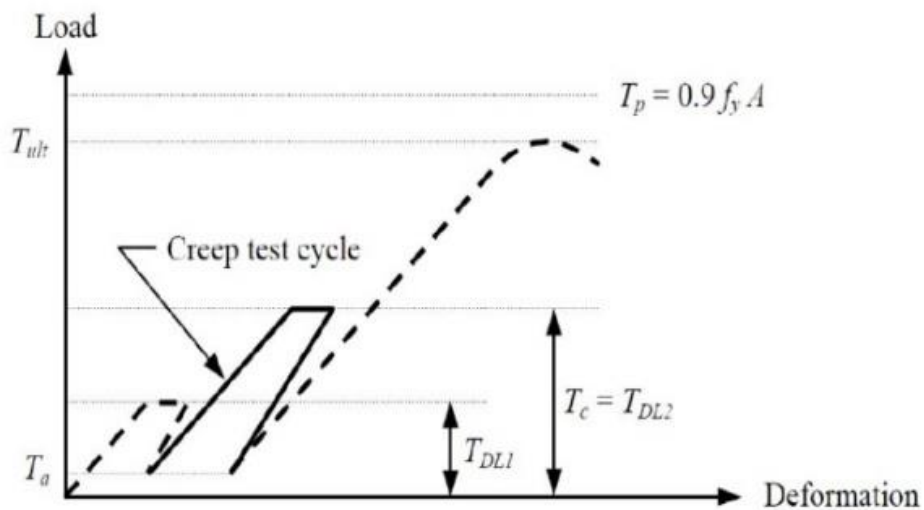
Figure 02 : Schematic Diagram of Load-deformation Cycle of a Creep Test as part of a Pullout Test

The test consisted of loading the nail axially with the hydraulic jack in progressive steps while recording the load applied and the axial deflection of the soil nail with respect to the time. The loading was continued until the load applied reached the specified maximum test load for the loading cycles, the soil nail shows significant deflection at lesser load or the nail was broken during loading. After the maximum test load was applied and maximum holding time is maintained unloading was begun.

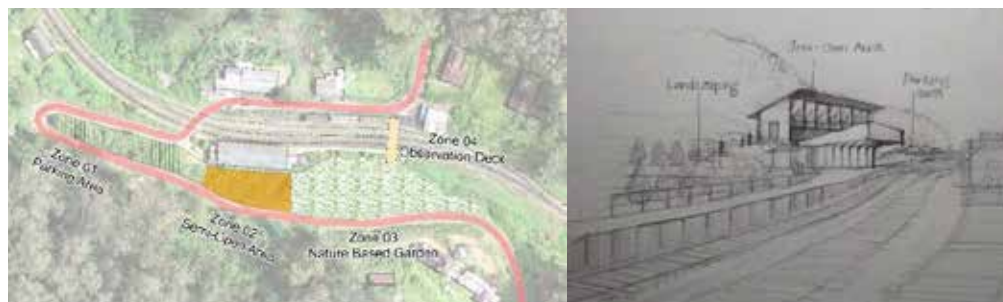
Figure 04 : Proposed Ohiya Station Development Plan

By understanding the development potentials of the area, proposed Ohiya Square Development mainly focuses on a parking area, semi-open area with waiting area, relaxing area and changing room for local and foreign tourists, gardening area with nature based landslide mitigations and observation deck.

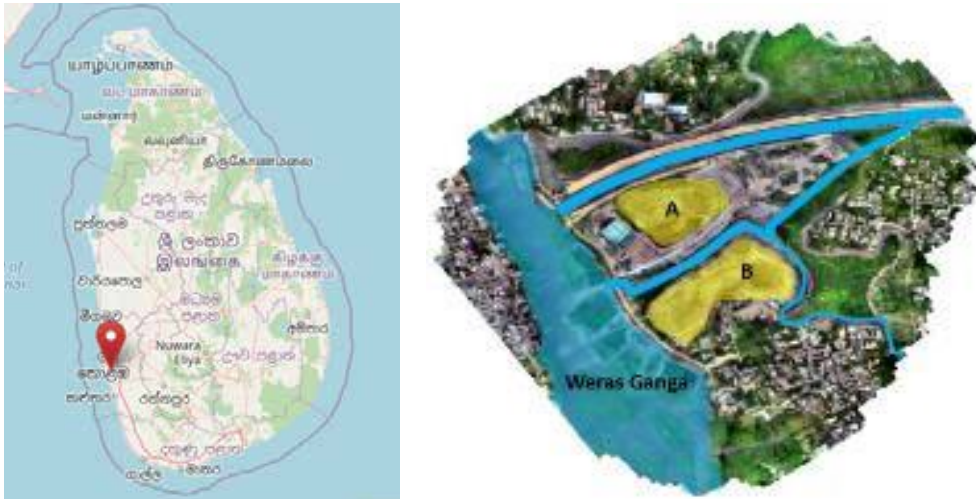
Figure 01: a) Karadiyana waste dump b) Surrounded canal system

This controlled dump is functioned as the final disposal facility for several Municipal and Urban Councils. Currently, the dumpsite is managed by the Western Provincial Waste Management Authority (WPWMA). The extent of the land allocated for waste dumping is 25 acres (approximately 10 hectares). The daily intake for the dumpsite is about 550 MT of Municipal Solid Waste (MSW). Because of the high MSW deposition on elevated levels, the dump is reaching its maximum capacity and thus posing a risk of landslide and slope failures to surrounding residential facilities. However, WPWMA as the regulatory authority, wanted to rehabilitate the waste dump in an environmentally friendly manner through application of scientific approaches. In this regard, National Building Research Organisation (NBRO) was requested to develop a technical design for the waste dump rehabilitation works. A flood risk analysis was conducted to identify safe flood levels in the area surrounding the dumpsite as a preliminary requirement for the geotechnical design works.

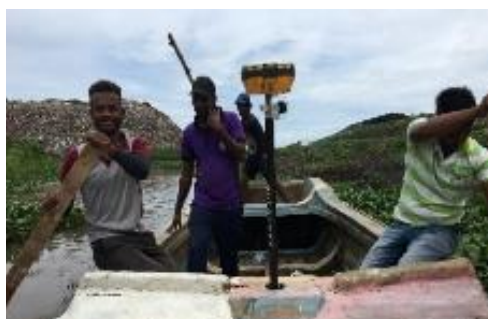
Figure 03a: Canal bathymetry survey

During the field observations, it was identified that some drainage paths were abandoned and clogged by aquatic plants such as Water Hyacinth (*Eichhornia crassipes*) due to lack of maintenance. Canal bathymetry survey and a spot level survey were conducted separately to identify existing capacities of the drainage paths and to identify elevation profile of the waste dump area and its vicinity (Figure 3).

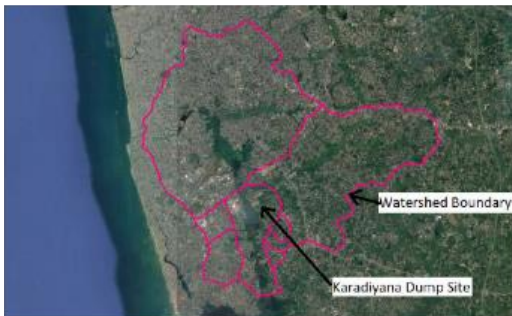
Figure 04: Catchment delineation for the Karadiyana dumpsite area

All sub catchments of the study area were delineated using the Digital Elevation Model (DEM), information obtained from the LIDAR survey by the Department of Survey and the spot level data obtained from the study area. Sub catchment map of the study area and updated IDF curve of the Rathmalana area are presented in Figure 4 and Figure 5, respectively.

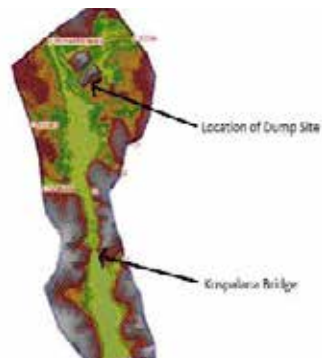
Figure 07: 2D model set up of the HEC RAS model

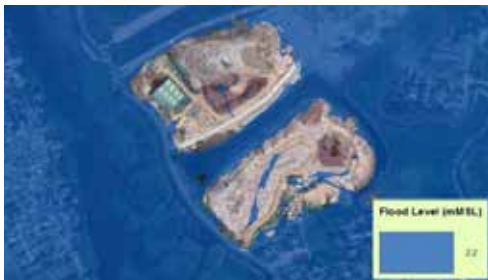
Figure 08: Flood Spread Map for 5 Year Return Period for raw terrain without dredged canals [Present Condition]

Flood spread maps and flood velocity maps produced by HEC RAS 2D modelling are shown in Figure 8 to Figure 9.

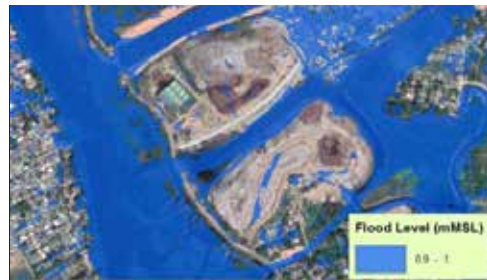
Figure 09: Flood Spread Map for 05 Year Return Period for raw terrain with dredged canals [Future Condition]

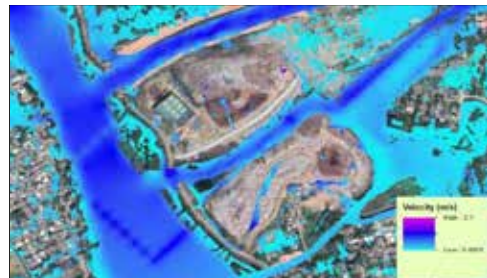
Figure 11: Flood Velocity Map for 5 Year Return Period for raw terrain with dredged canals [Future Condition]

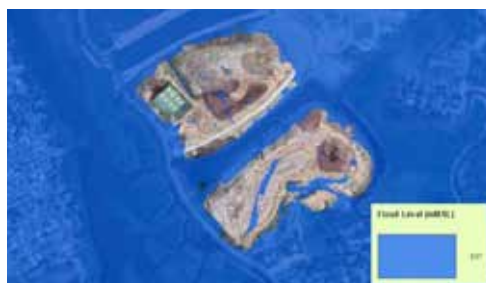
Figure 12: Flood Spread Map for 100 Year Return Period for raw terrain without dredged canals [Present Condition]

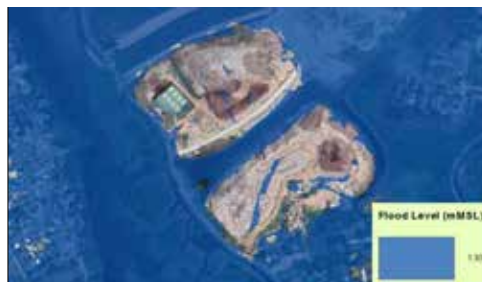
Figure 13: Flood Spread Map for 100 Year Return Period for raw terrain with dredged canals [Future Condition]

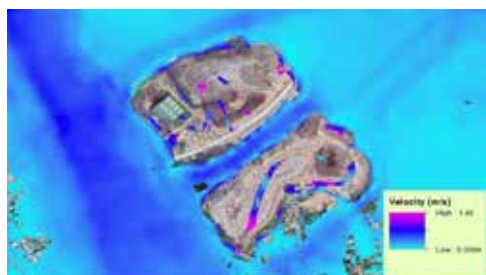
Figure 14: Flood Velocity Map for 100 Year Return Period for raw terrain without dredged canals [Present Condition]

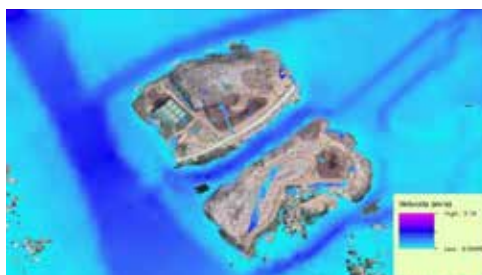
Figure 15: Flood Velocity Map for 100 Year Return Period for raw terrain with dredged canals [Future Condition]

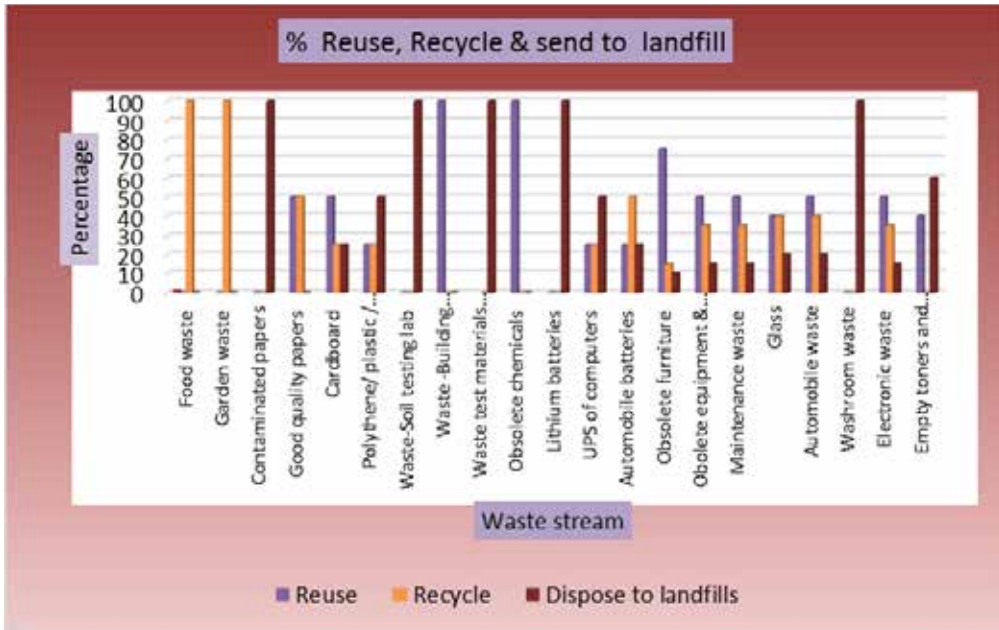
Figure 03: Percentage Reuse, Recycle & send to landfills

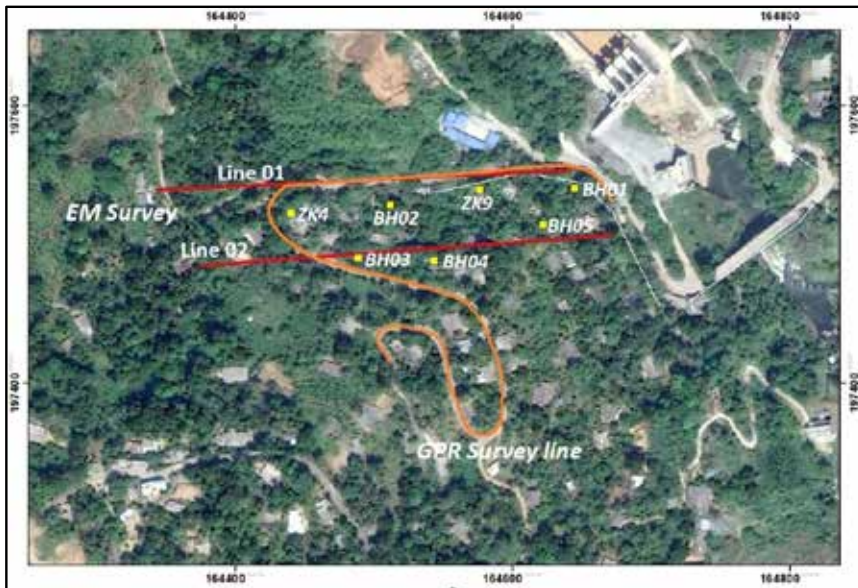
Figure 03: Locations of resistivity sounding, GPR survey lines and core drilling locations of study area (1:1000)

An electrical resistivity survey had to carry out to identify most of the terrain geology by covering adjusting areas of the study area. Topographic features were observed by using five Vertical Electrical Sounding (VES) lines. Figure 3 shows the ER survey profile along the original tunnel route. It clearly shows that the tunnel is running through clay-filled cavities and in fresh rock (right-hand side), on top of the tunnel there are series of highly saturated clay-filled cavities. This can be seriously affected the tunnel construction, itself and also the structures above the tunnel trace with a considerable width (50 m width apart from tunnel trace). This needs to be critically considered during the construction of the tunnel. A proper supporting system during the construction and a properly designed tunnel lining to support the load of upper layers, and must not give a possibility to seep water from upper layers to the tunnel after the completion of the tunnel lining.

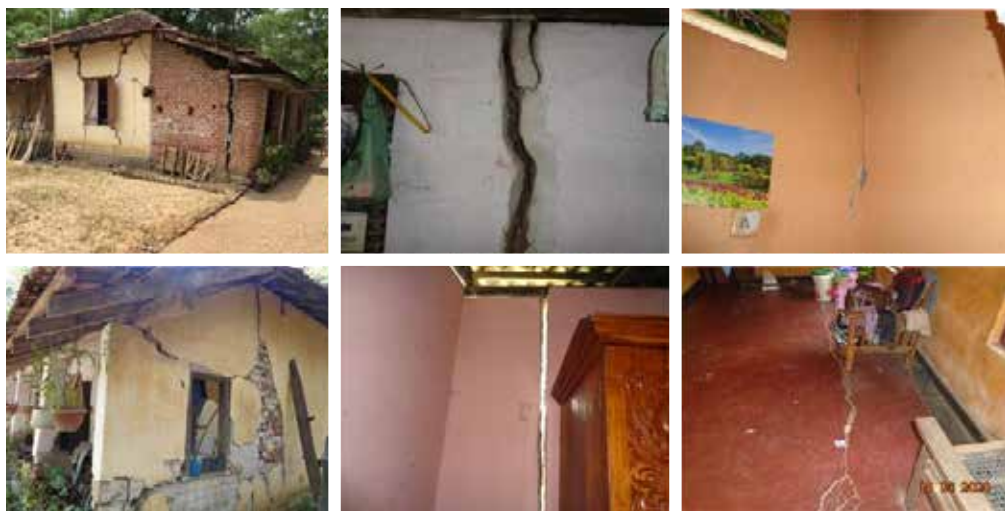
Figure 01: Damaged houses

Since, the above 58 houses are located in an area where an expansive soil layer is present, swelling during the wet season and shrinking during the dry season is identified as the main reason for structural distress and an appropriate foundation design with necessary guideline on detailed construction process in necessary.

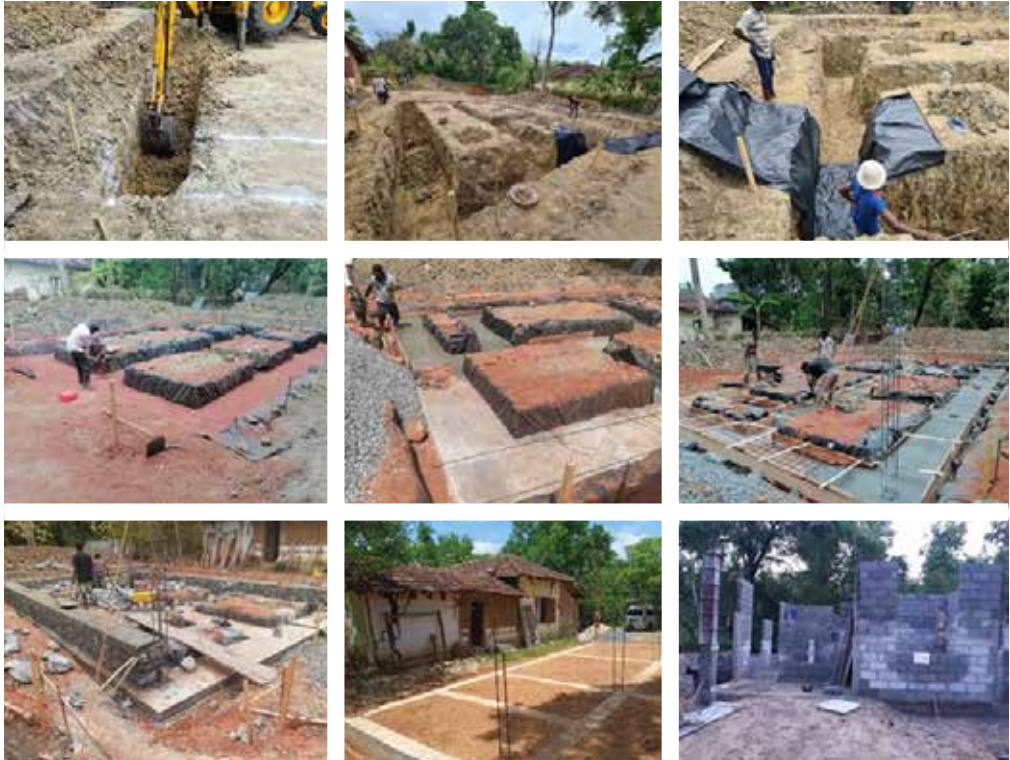
Figure 07: Images of construction of the resilient model house as per the Foundation Type 1

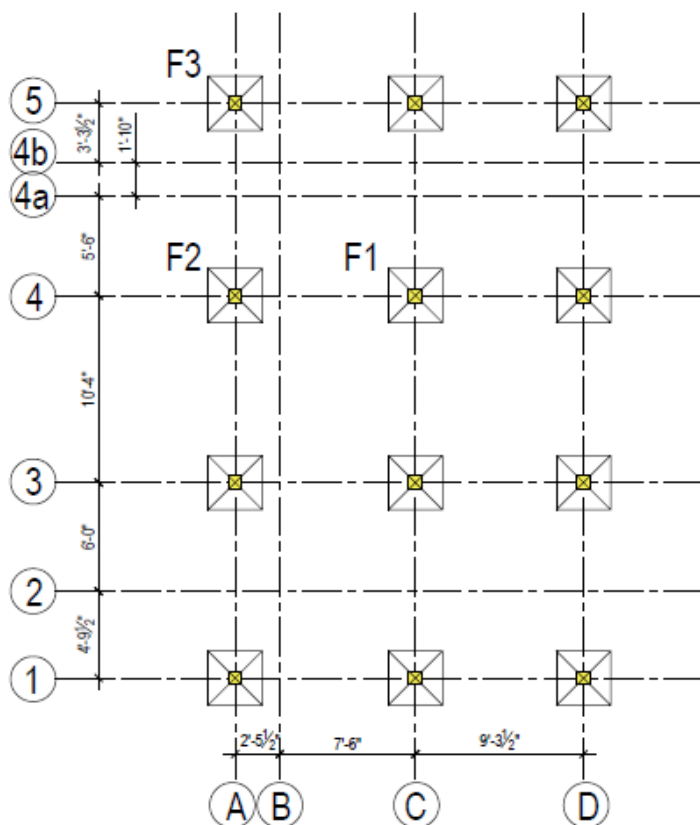
Figure 08: Footing Layout

Column footings layout proposed with foundation type 2 is shown in Figure 08

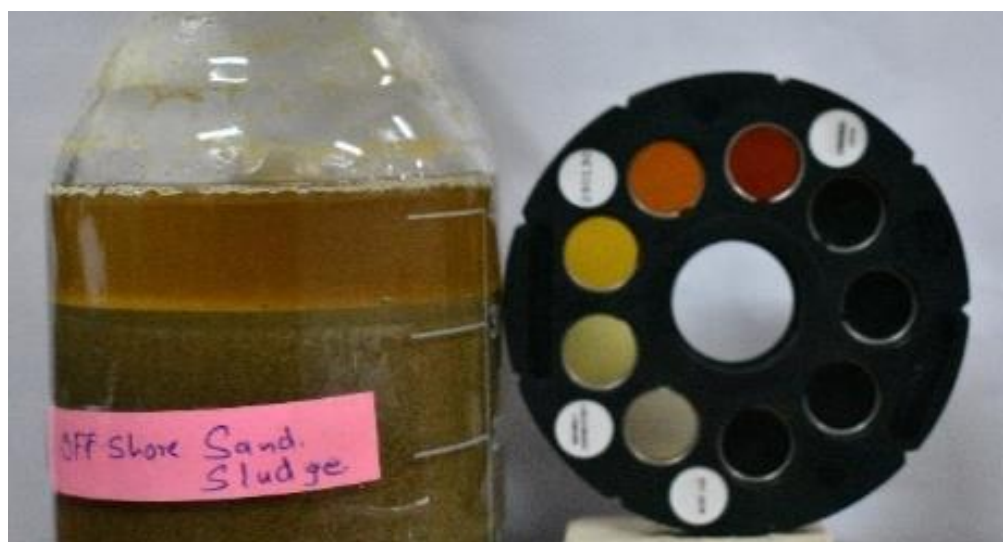
Figure 02: Supernatant color comparison with standard color plate according to ASTM C40

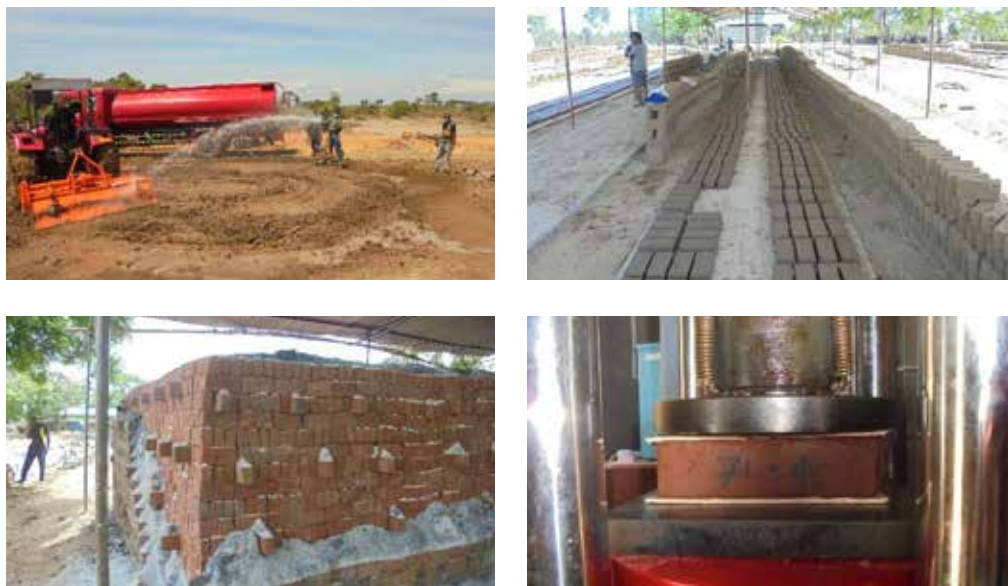
Figure 01: Brick making process and the test for compressive strength

Suggested improvements were introduced in the following stages in the clay brick manufacturing process. Those improvements and the testing of fire brick were shown in Figure 1.

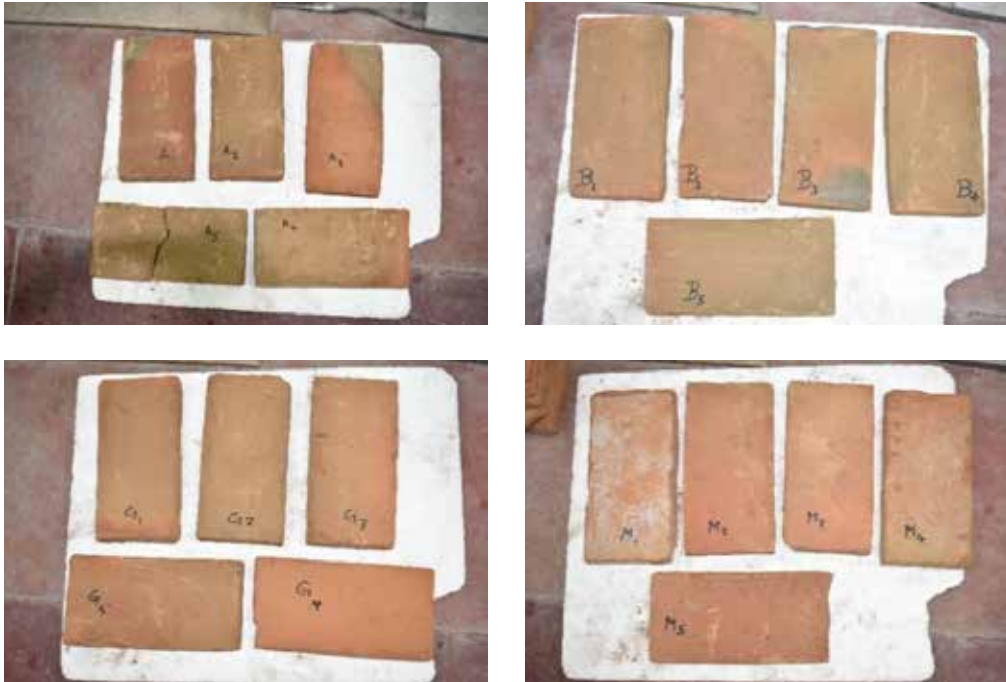
Figure 02: Received samples from four different locations (a) Alayapaththu, (b) Bogoda, (c) Galkadawala, and (d) Mahiyanganaya

The conditions of the delivered samples were also recorded. Then the samples were oven - dried at 110 °C. After 24 hours, the weights of the bricks were recorded and the samples were immersed in the water bath. The test for compressive strength was conducted after 72 hours. The samples were not tested for the maximum bearing load due to its' extreme compressibility. Therefore, the compressive load was recorded at the initial crack observed. The testing was conducted according to the test standard of SLS 39: 1978 (SLS : 39, 1978) All the statistical analyses were conducted by using the software Origin Pro Lab (Origin 8.5, 2010).

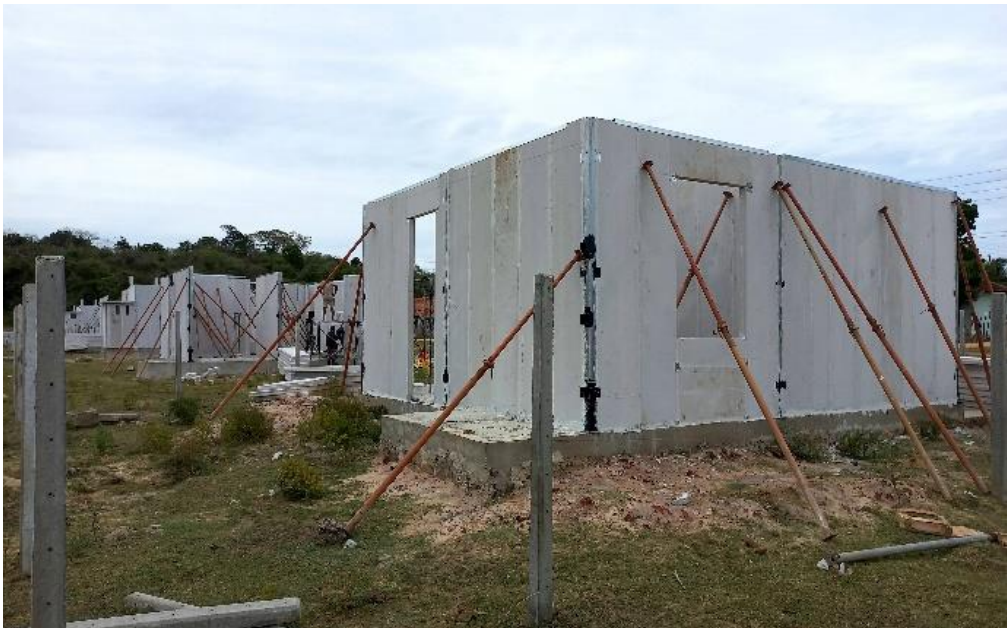
Figure 04: Superstructure works

In conventional building construction methodologies, Superstructure works take around 3 times higher duration than substructure (M.Madhu & K.Hemanth Raja, 2017). Therefore, more advanced techniques were introduced to replace conventional methods. Usage of precast panels instead of brick walls produces a substantial time saving as well as a cost reduction. In addition to that, when most of the structural elements are fabricated with lightweight materials, transportation and fixing can be done in an effective manner with less labour requirements. In proposed construction method, there are 3 major criteria in Superstructure such as; 1. Column mounting 2. ALC panel fixing 3. Door and window connection.

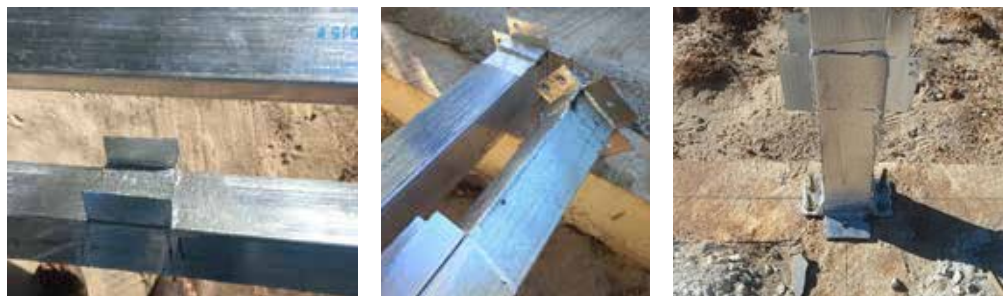
A 4"x 4" Steel column infilled with Grade 25 concrete for 300 mm from the bottom acts as a load - bearing element and also increases the structural rigidity when connected with the ALC panel wall and roof structure. The column is mounted using four M16 x 190 chemical bolts to the plinth beam. C-channels are connected along column height to have a proper connection with the wall. Since most of the column volume is a hollow rectangular section, it is very convenient to erect with a minimum labour force in a short period.

Figure 05: Steel column

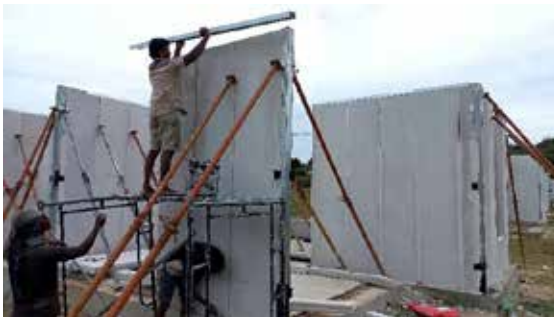
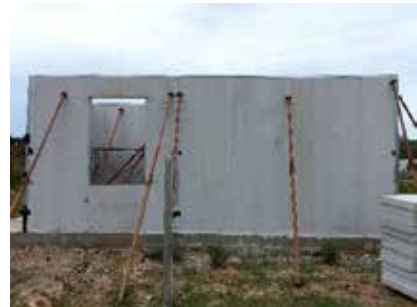
Each ALC panel is having dimensions of 600 mm in width and 3 m in height and the thicknesses of the panels are 100 mm and 200 mm. Column - wall connection is done by fixing the C-channel with the column firmly using nut and bolt connection and the ALC wall is fixed with the C-channel. Roof trusses also rest on the C-channels which are mounted on top of the wall and they are connected using L-connectors on both sides. Panels are connected with each other using tongue and groove joints by applying a special adhesive. In addition to that, 6 mm diameter nails are inserted in a way to create a 30-degree downward inclination between the panel edges which are perpendicularly intersecting to increase the structural rigidity.

Figure 06: Connection between panels

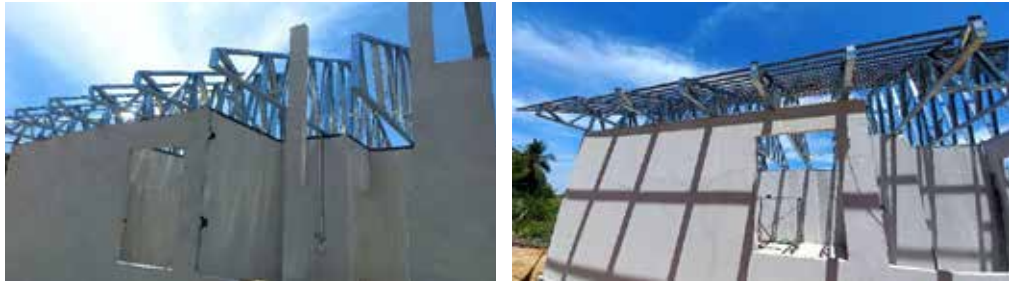
Roof structure design was concentrated on load reduction so the elements were designed with lightweight materials. Galvanized Light Gauge Steel (LGS) was used to fabricate the truss section and also fibre cement board and PVC materials are used for the ceiling. However, Calicut roof tiles were selected as the roof covering based on the cultural requirements and also by considering the higher temperature conditions in North and Eastern Provinces, even though the weight is significant. Each of the metal elements is expected to comply with the tensile properties as specified in the standards.

Figure 07: Roof structure and connection

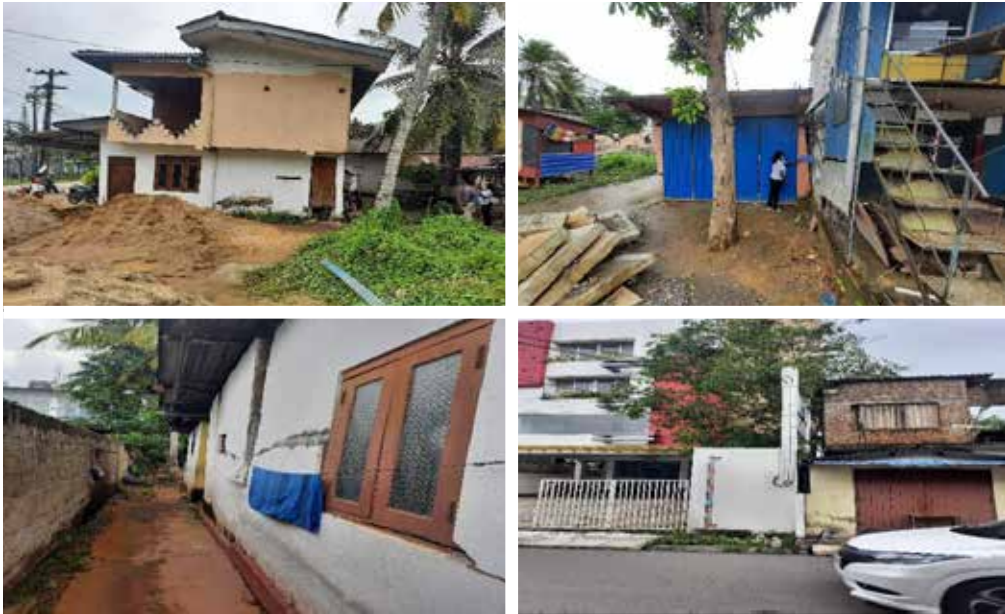
Figure 01: Adjacent building failures and settlement cases around Galle Municipal area

National Building Research Organisation (NBRO) is one of the regulatory institutes in building constrictions in Sri Lanka, which provides guidelines on planning and development activities, standard reports on buildings and constructions, damage assessments and technical solutions and research and development activities on the utilization of areas with technologically problematic soils. Over the last few years, NBRO and other local authorities in Galle have received many complaints regarding building settlements and construction failures in the pre-existing adjacent buildings due to intense construction activities carried out in the Galle Municipal. As per the records of NBRO, an increasing trend of these hazards, and complaints are seen due to a lack of understanding about the subsurface conditions around the sites. Most of these incidents have been reported from Dangedara, Hiribura, Karapitiya, and Koggala Kade areas where initial field investigations have concluded that the possible reasons for most of these failures were differential settlements and angular distortion in the buildings, where the subsurface mostly consists of marshy fillings which are saturated with water bodies (fig. 01).

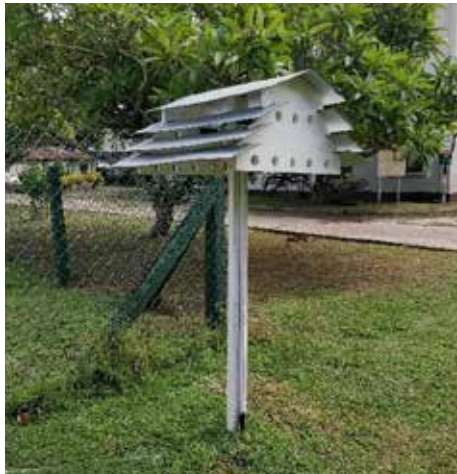
Figure 02: Installation of Monitoring Unit at Colombo Urban Area

The real-time air quality monitoring units were installed in each selected site in a special type of shelter with a height of 2.5 m to minimise air movements. Overview of sampling unit installed at sites are shown in Figure 2 to Figure 6.

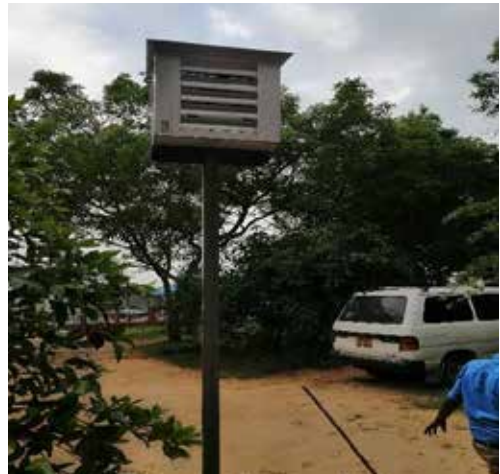
Figure 03: Installation of Monitoring Unit at Kurunegala Urban Area

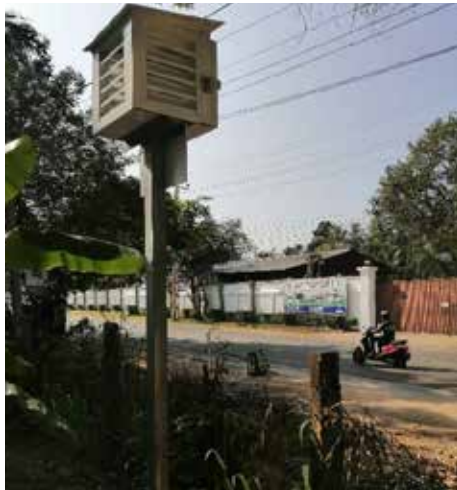
Figure 04: Installation of Monitoring Unit at Anuradhapura Urban Area

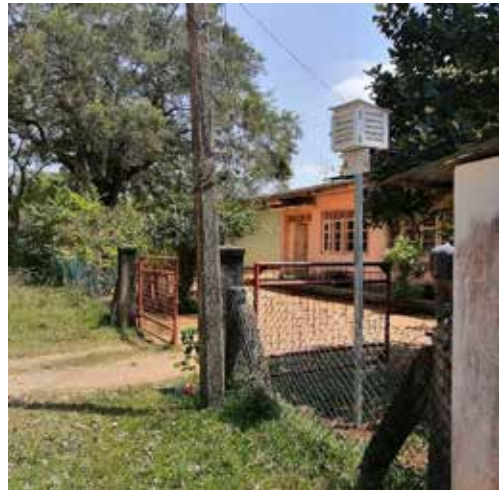
Figure 05: Installation of Monitoring Unit at Vavuniya Urban Area

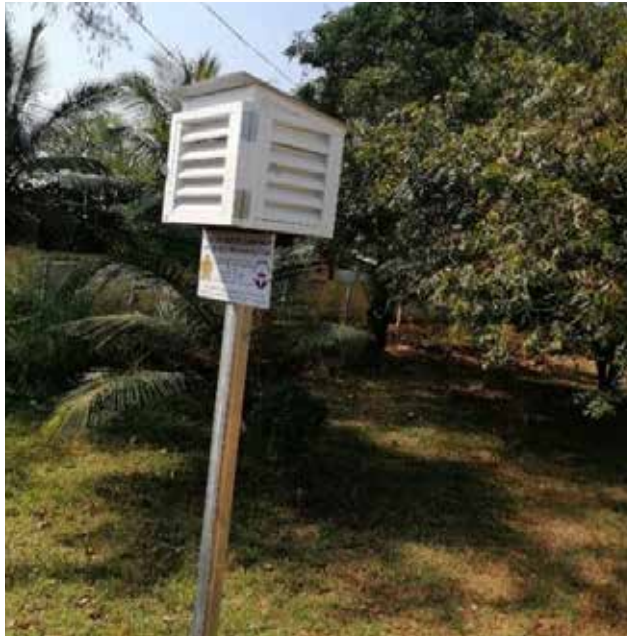
Figure 06: Installation of Monitoring Unit at Jaffna Urban Area

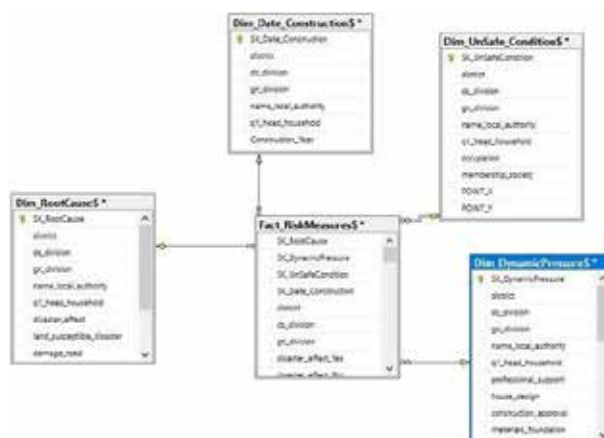
Figure 05: Proposed design-based on star schema

In order to facilitate the analysis of landslide risk related information, star schema-based dimension modelling is proposed after considering the simplicity of the data warehouse design and to enhance the better query performance. Star schema consists with a fact table and number of dimension tables. Fact table contains the foreign keys (here surrogate keys are used) of available dimensions measures.

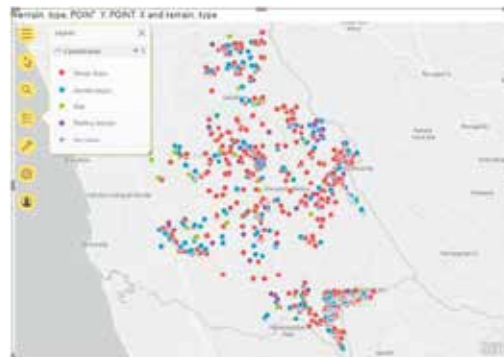
Figure 08: Spatial distribution of the houses by Terrain type

Identifying the spatial pattern helps to correlate the household properties with landslide hazard zones, which gives crucial idea on how the location of the houses can expose to risk, by combining the location, and construction year and other properties, it is possible to predict the trend of settlement development, based on those trends, decision - makers can take preventive measures or control the construction of houses in high hazard area.

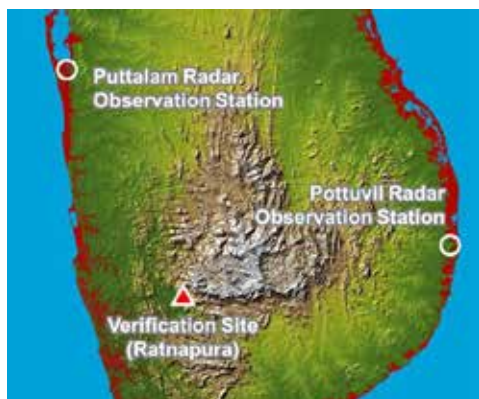
Figure 04: Planned location of C-band Doppler weather radar stations by JICA
Source: FRUNO

The C-band weather radars are planned to be install at Puttalam in the western coast and Pottuvil in the eastern coast (JICA, 2016). The location of the radar installation sites are given in Figure 4. Figure 5 shows cross-sectional views between the installation sites

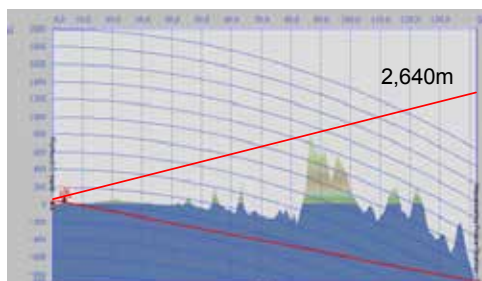
Pottuvil to Ratnapura

and Ratnapura area, taking into account the curvature of the earth's surface and the refraction of radio waves by the standard atmosphere. These represent the line-of-sight relationship when actually observed by C-band radar. Since there is a terrain range between them, a part of radio waves are blocked. The lowest altitude observable from Puttalam is approximately 2,170 m above ground at Ratnapura, and from Pottuvil approximately 2,640 m.

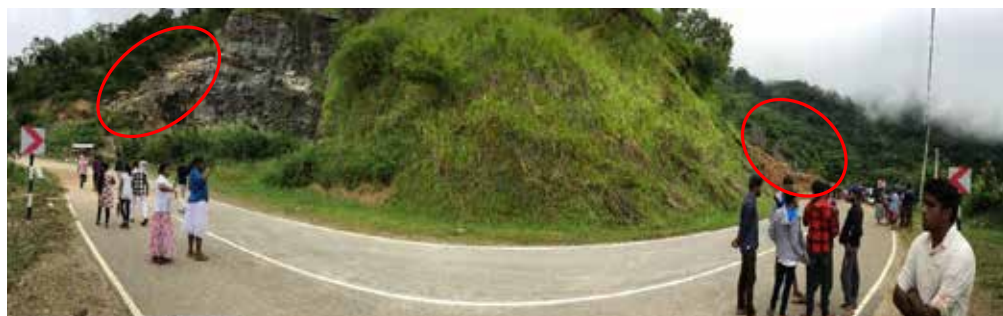
Operation of a “A” Grade rock quarry belongs to HUNAN Construction Engineering Group Corporation located about 50m ahead from the initiation area contributed to triggering of landslide (Figure 01).

Figure 01: Rock quarry (left) with the landslide initiation area (right)

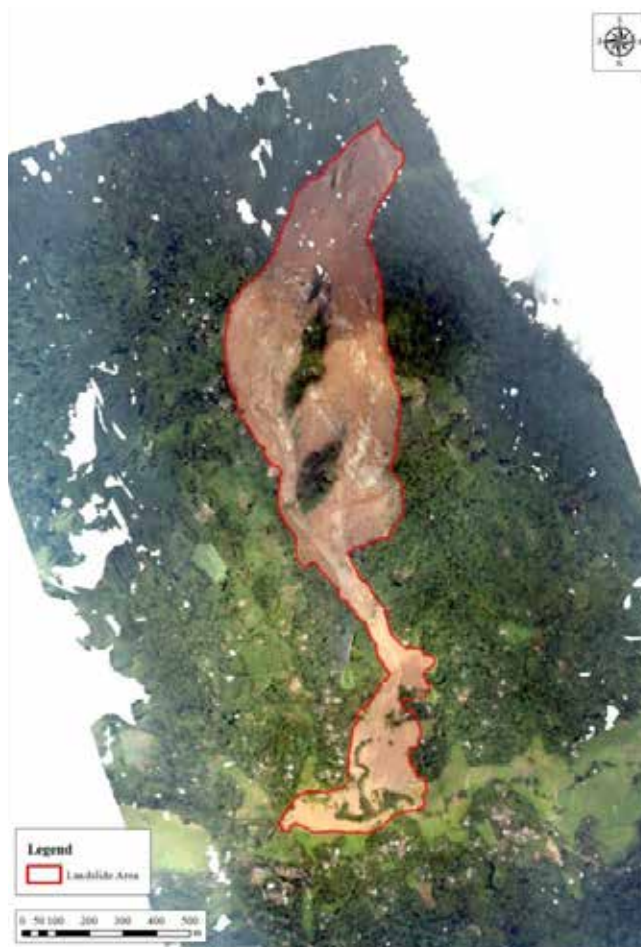
Province	Sabaragamuwa
District	Kegalle
Divisional Secretarial division (DSD)	Aranayake
GPS	7.154736 N, 80.430149 E
Date of Occurrence	17 th May, 2016
Time of Occurrence	4.30 pm
Initiation width	175 m
Initiation depth	10 m
Initiation length	243 m
Initiation Area	40,541.4 m ²
Damages	31 deaths / 96 missing 523,626 m ² damaged

Figure 03: Aranayake Landslide (Source: JICA Report)

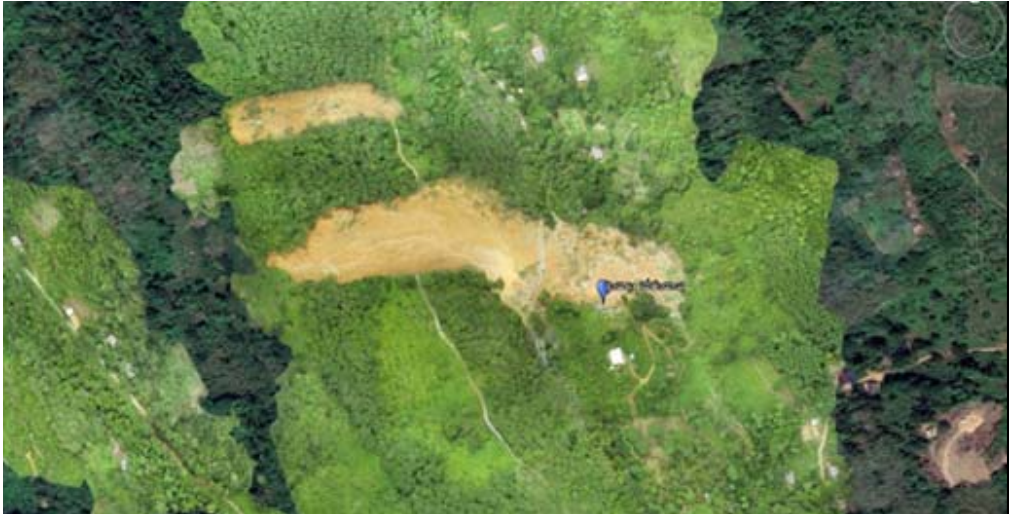
Figure 03: Drone image of the landslides

The scale of the disaster was massive. The length of the debris flow is about 400 m long. The main scarp is about 18 m long and 8 m deep (Figure 03).

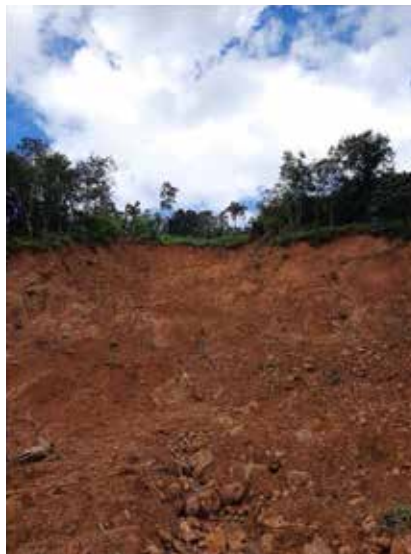
Figure 04: Main scarp of the Dumbara landslide

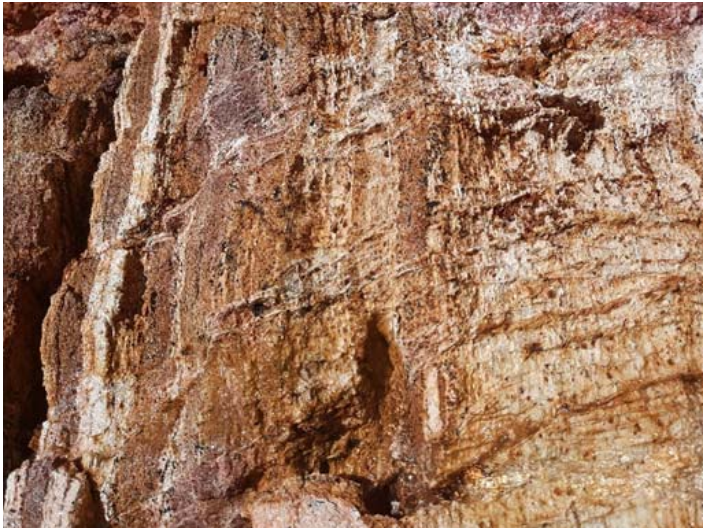
The pegmatite intrusion along a joint plane has resulted in a higher percentage of completely weathered feldspar in the immediate soil layers which led to planes concentrated with clay. Fractional amounts of graphite were also identified in the area. Both these factors act as a favorable condition to creating a slip surface.

Figure 06: Clay rich bedrock

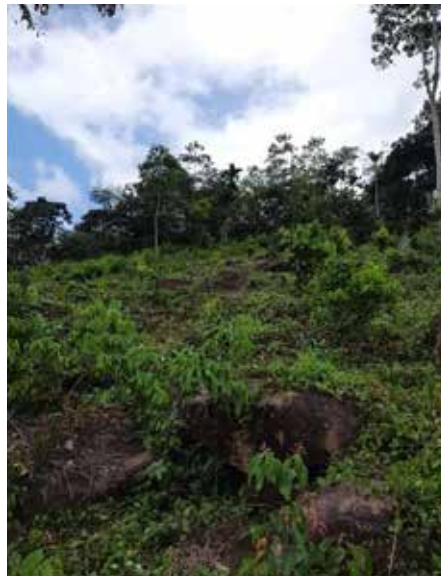
Also, it was identified that the immediate portion of the land on the upper slope was lately cleared. This led to more infiltration under heavy rains.

Figure 07: Cleared land above the main scarp

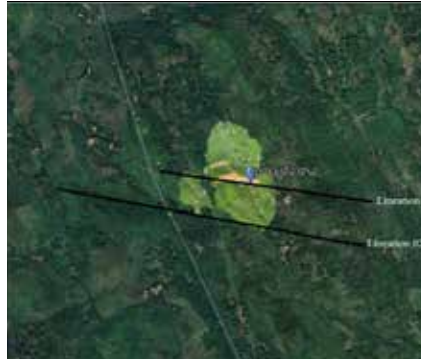
Further analysis shows that the initiation area of the landslide overlaps with an intersection of a Regional lineation and the slope direction. Usually, a Regional lineation

Figure 08: Distribution of lineations

remarks a weak zone of the bedrock. Also, the slope is on a limb of the Dumbara synform. This indicates that the underlying zone is a Fault/ Fracture zone.

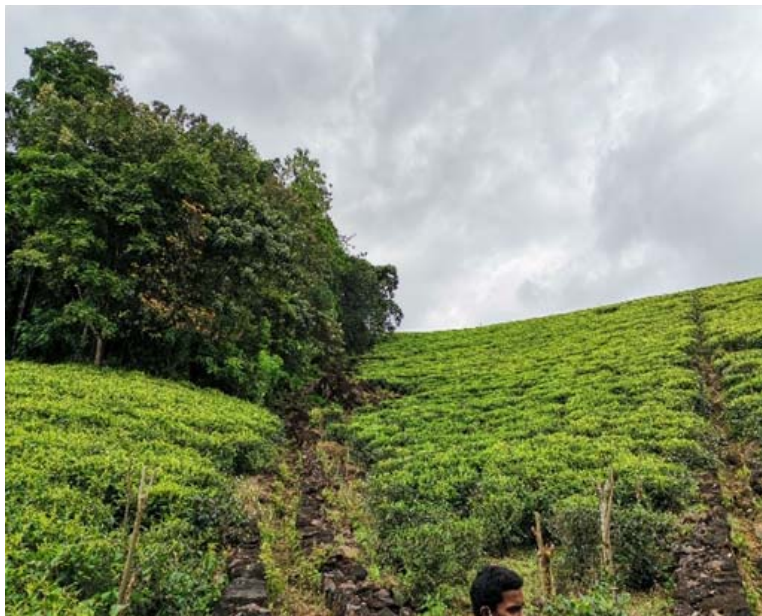
The fertilized tea land consists of a tea cultivation which is monitoring by Galaboda tea estate. That tea land is fertilized by the tea estate after every 45 days. The current tea plantation has commenced in 2017 and since then the estate management has used two types of fertilizer types as T-750 and U-709 which containing Nitrogen, Phosphorus, and Potassium with respective ratios. Estate management has used T-750 in the year 2017 and after the year 2018 they have used U709. As the tea estate mentioned the forest part has not fertilized in the recent past.

Figure 04: Actual image of the fertilized and non-fertilized fields mentioned in the study area

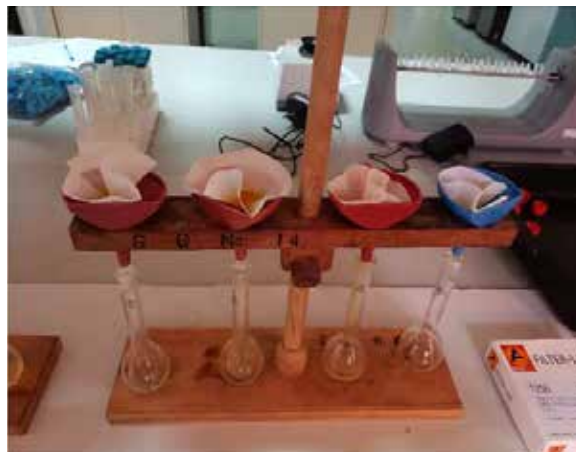
Soil samples were collected from each fertilized and non-fertilized land at 20 cm intervals to 1 m depth starting from the surface. All cations available in the soil samples and their concentrations were calculated using this test. 0.1 g of each representative sample was used for digestion.

Figure 06: solution preparation for ICP-MS test

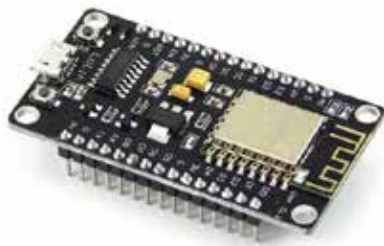
Node MCU (Figure 01) (Arduino on ESP8266, n.d.) is an open source IOT (Internet of Things) (Internet_of_things, n.d.) platform integrated with ESP 8266 (WiFi Module - ESP8266, 2021) (Figure 03) low cost Wi-Fi based microchip with full TCP/ IP stack and microcontroller capability (NodeMCU DEVKIT, 2021). The Node MCU was invented after ESP 8266 chip was invented by Espressif Systems in 2013 (Esp8266, 2021). Pin configuration of Node MCU and ESP 8266 are shown from Figure 02 to 04.

Figure 01: Node MCU
 (source: Google Images)

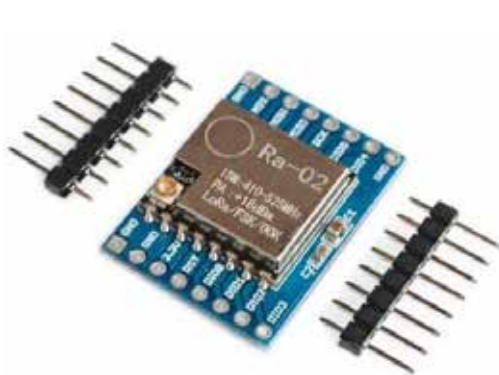
LoRa (Long Range) (What Is LoRa, 2021) (Fig. 2.1) is a low power wireless data communication system that supports a long-range connection (Figure 05). It uses a radio frequency modulation technique that is generated by SMTECH LoRa Transceiver chip. LoRa uses frequency bands like 433MHz in Asian countries, 868 MHz in European countries and 915 MHz in North America. In 2018, SMTECH announced new LoRa chipset with reduced power consumption and increased transmission range. Now, LoRa have a coverage area more than 5 Km in rural areas.

Figure 05: LoRa Module
(source: Google Images)

When using a LoRa module, it has advantages as well as disadvantages (LoRa | Advantages of LoRaWAN | Disadvantages of LoRaWAN). Low cost, long coverage, and low power consumption are the advantages, and unsuitability for high-data rate transmission, inability to transmit frequently, and difficulty to use on highly populated networks are the disadvantages of LoRa.
