## 12<sup>TH</sup> ANNUAL RESEARCH SYMPOSIUM - 2022

**Building Resilience amidst  
Economic Challenges**

# SYMPOSIUM PROCEEDINGS

26<sup>th</sup> January 2023  
Colombo, Sri Lanka

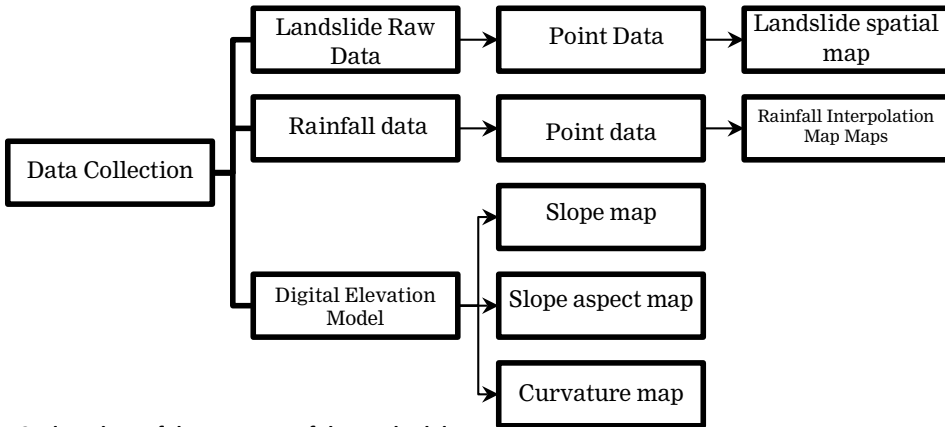
Figure 2: Flow chart of the summary of the methodology

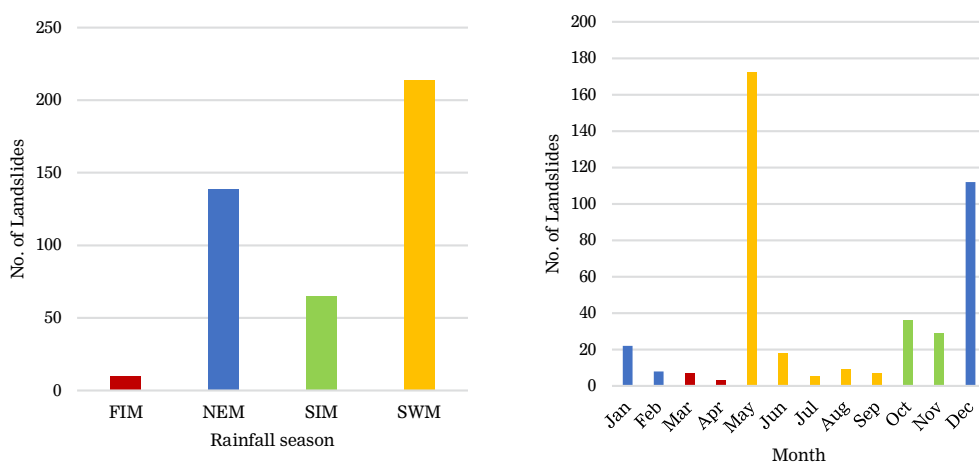
Figure 6: Recorded number of landslides with rainfall seasons and months

The records of landslides are high in the months of May, and June, and once again from October to January, indicating a clear relationship with monsoon seasons respectively (Figure 6). This confirmed that rainfall is a major causative factor of landslides in the area. The low amount of recorded landslides in the period of February to April and July to September, reflects relatively dry conditions in the area. These results confirm Rathnaweera *et al.*, 2013 that landslide events have mainly followed the path of two monsoons in Sri Lanka. Although the rainfall intensity may be the same in different regions, landslides may or may not occur according to the geological and topographical characteristics.

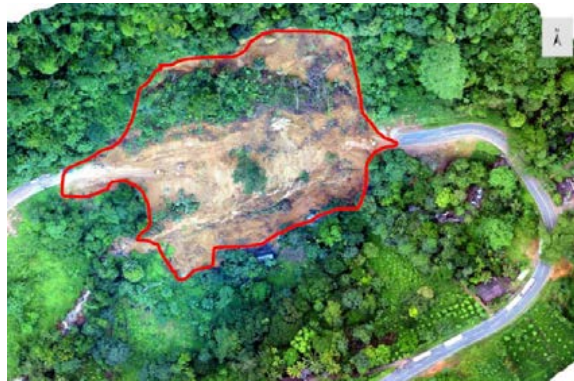
**Figure 1: Drone image of Durekkanda landslide area**

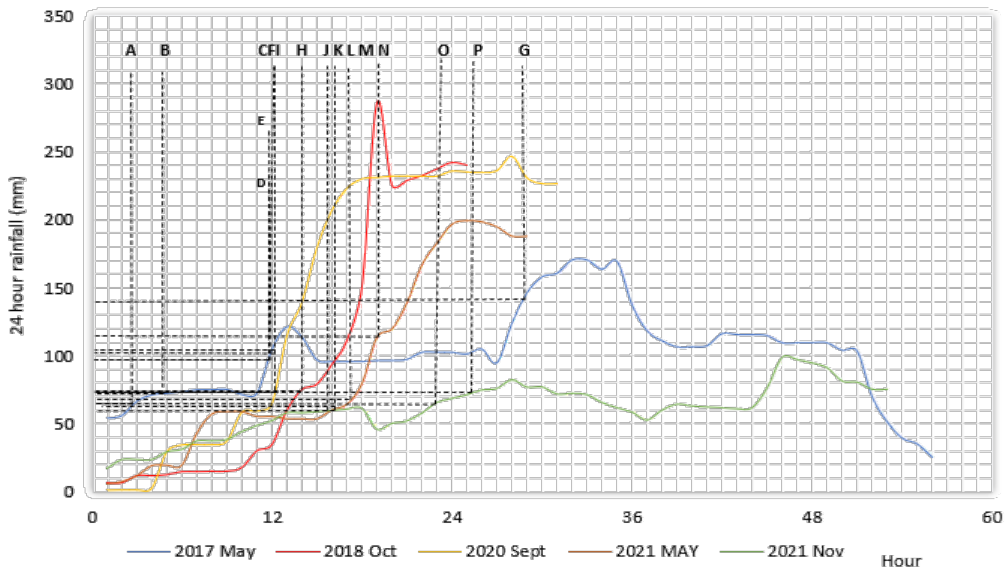
Figure 3: 24-hour rainfall for cutting failures occurred in past few years

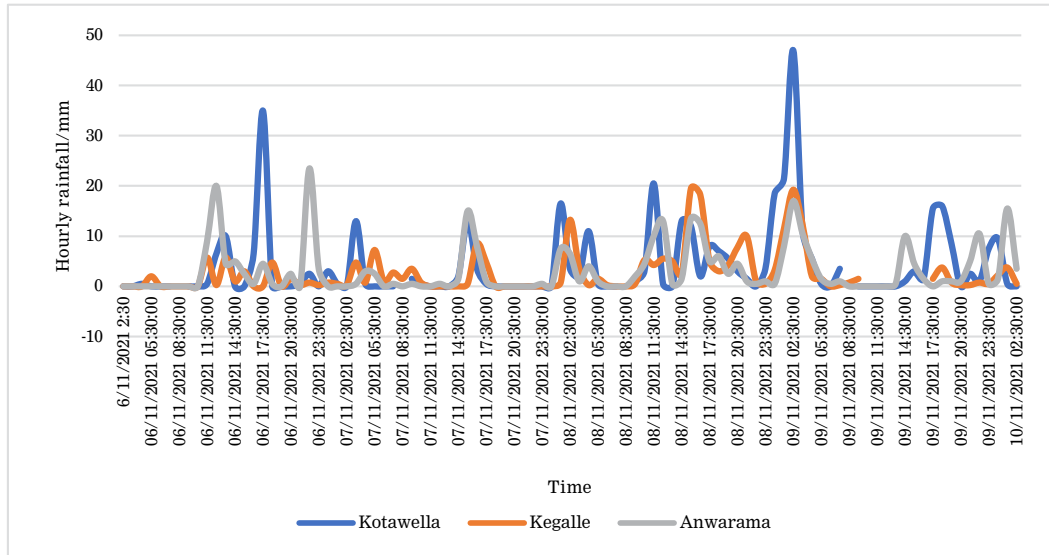
Figure 4: 1-hour rainfall values for each hour from 06/11/2021 02:30:00 to 10/11/2021 02

According to Error! Reference source not found., Kotawella exceeded the 24-hour threshold value, whereas Anwarama and Kegalle MV did not exceed the 1-hour or 24-hour rainfall threshold limits. But considerable incidents were reported in the Anwarama and Kegalle MV basins. In general, the results show that landslides can occur even with low, intense rainfall if it falls for an extended period of time. Hence, it is important to consider 48-hour and 72-hour threshold limits in EW.

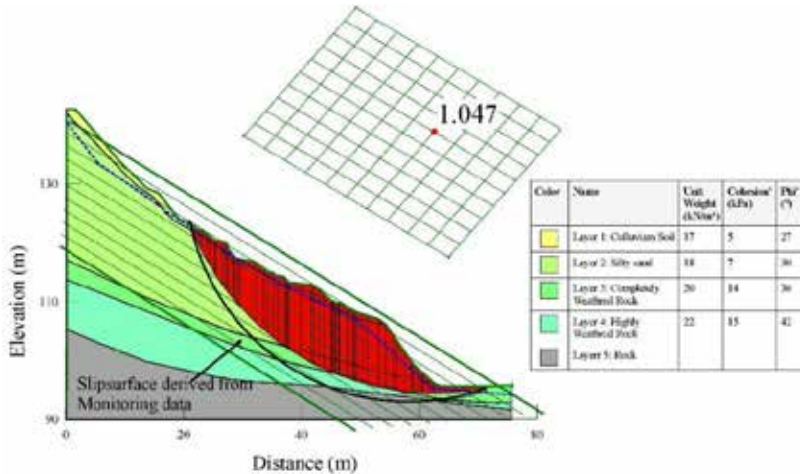
Figure 9: Stability analysis result

Stability analysis was carried out after the preparation of the subsurface geological profile along sections A – A, based on the results obtained from a detailed geotechnical investigation including the relevant laboratory tests. Figure 9 shows the stability analysis and the Factor of Safety (FOS) observed. Stability analysis of the proposed sections was carried out using the ‘Geo Studio SLOPE/W software considering the Spencer method. The ‘Grid and Radius’ option was used to obtain the critical slip surface with a minimum FOS. In the analysis, it was assumed that the potential failure plane strikes parallel to the maximum slope direction.

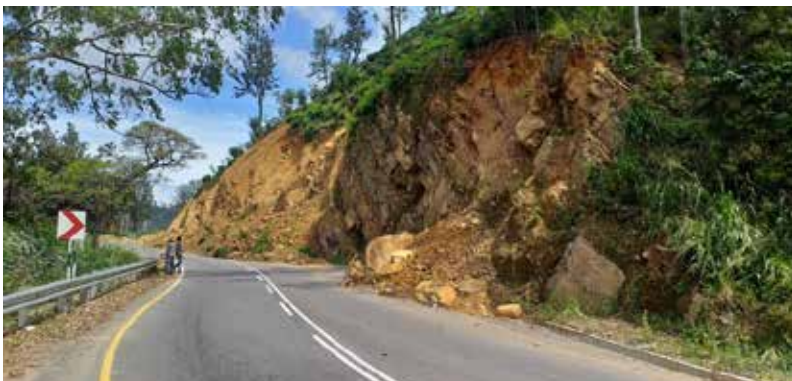
Figure 1: Road cut failure at Ch 140+560 of Peradeniya - Badulla - Chenkaladi Road (A5)

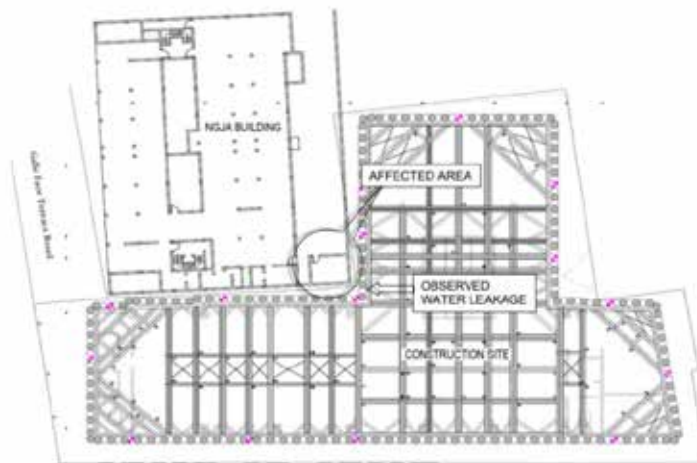
Figure 2: Plan view of the leakage point and the damaged location <sup>[2]</sup>

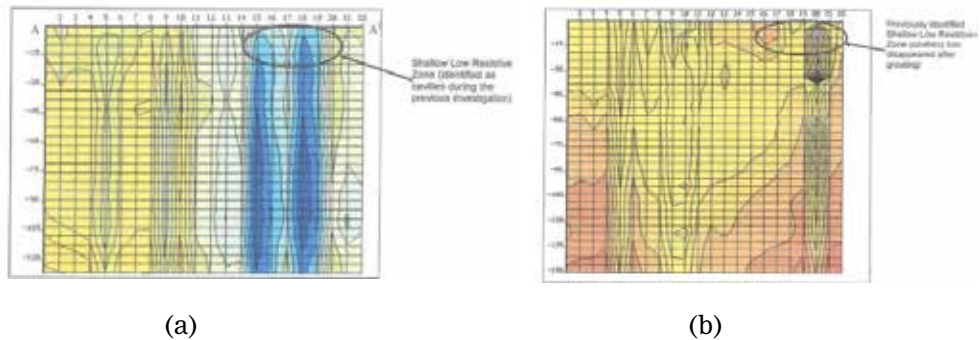
Figure 9: (a) Results before grouting; (b) Results after grouting<sup>[9]</sup>

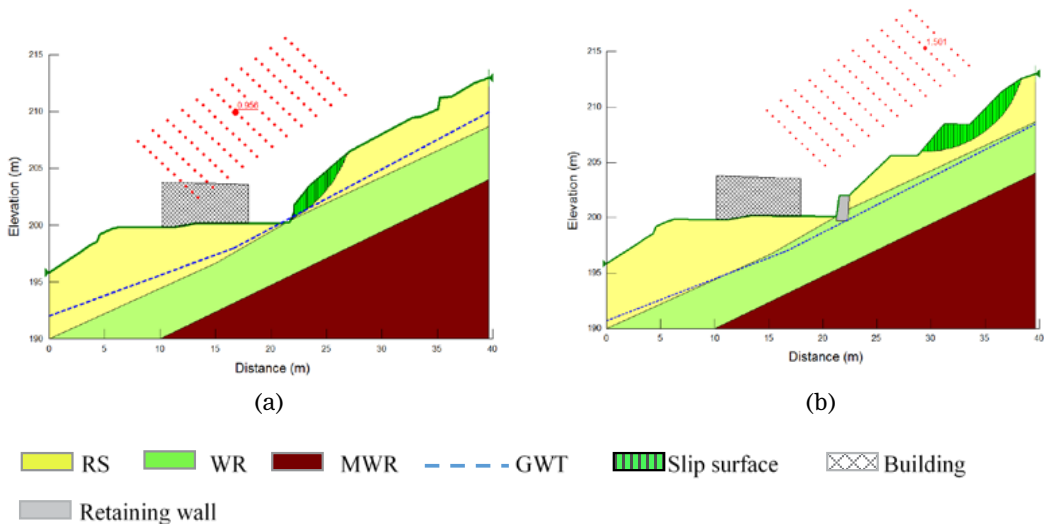
**Figure 1: (a) Analyzed cross section-B under the present conditions, (b) Analyzed cross section-B with countermeasures at location 1**

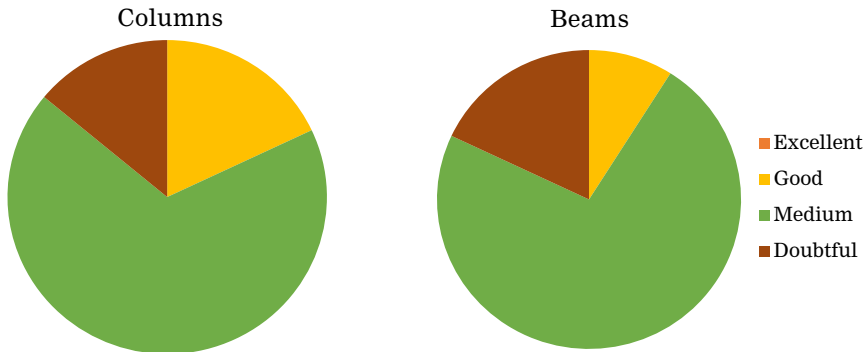
Figure 12: The graphical representation of total UPV results; column & beams

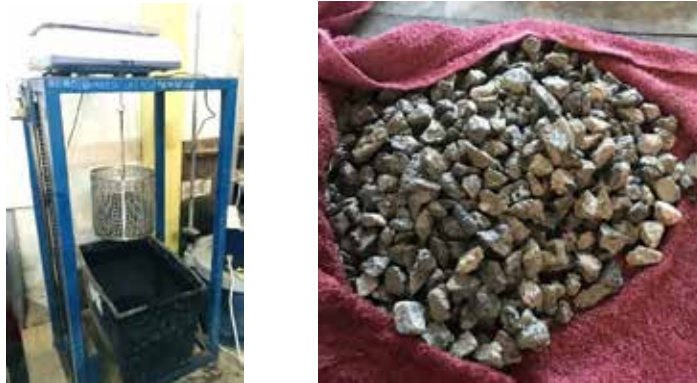
Figure 1: (a) specific gravity frame, (b) SSD aggregate sample

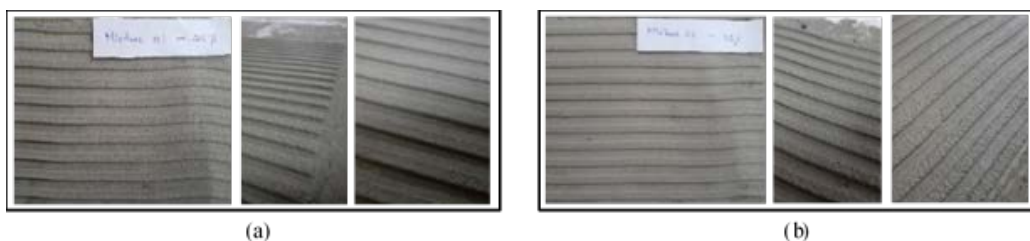
**Figure 2: Cracking inspection results (a) M1 (b) M2**
